CASTELLA MARIS BALTICI 6

NORWEGIAN CASTLES NORTH OF THE ARCTIC CIRCLE

Burgen in Norwegen nördlich des Polarkreises

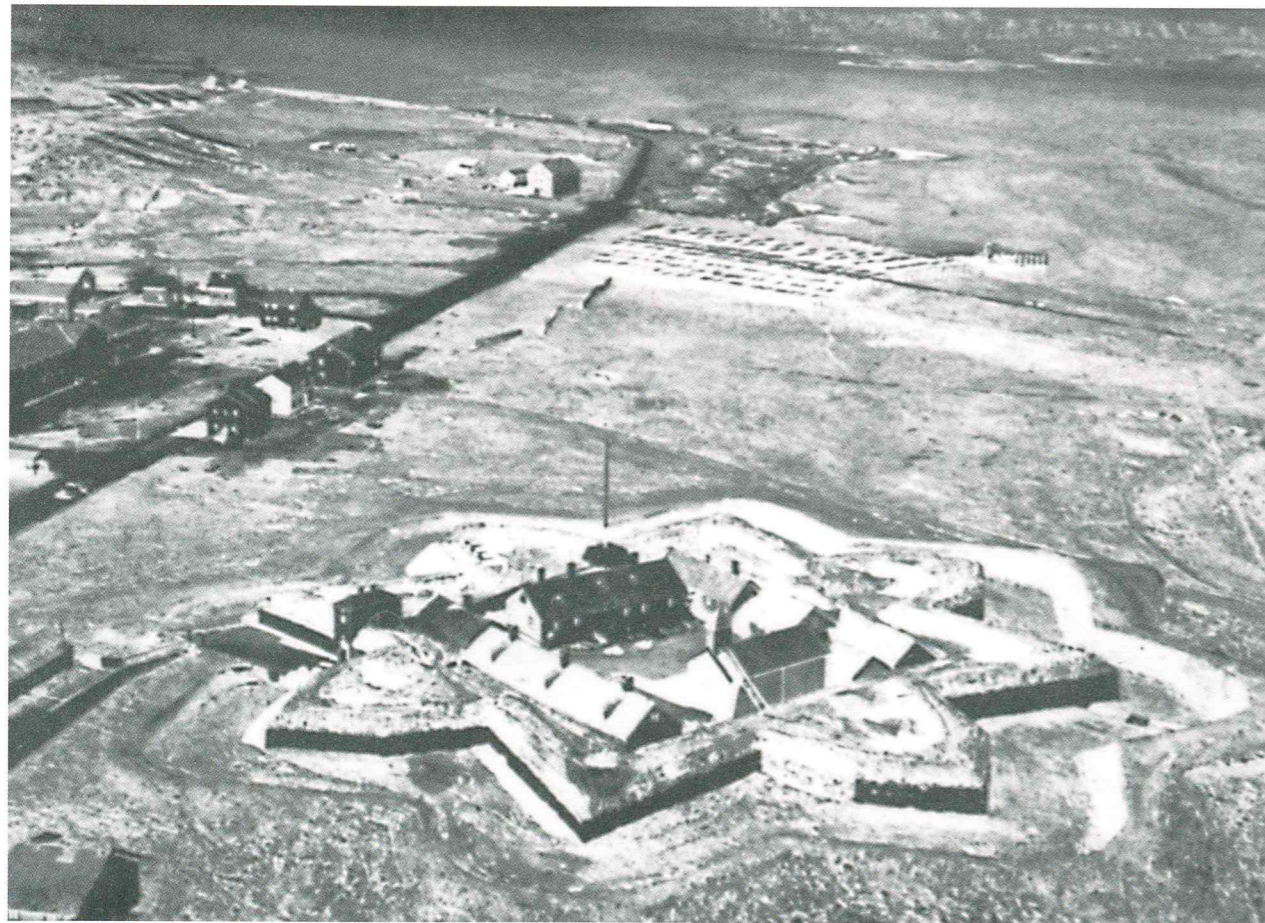
Fig. 8. Vardøhus Castle from 1738, looking west. In the background the mainland of Finnmark. Photo from the 1950s in Riksantikvaren's Archive, Oslo

Between 1734-38 a new, star-shaped fortress was built some hundred meters further to the west (fig. 8). This fortress did miraculously survive World War II, when the town of Vardø was bombed and almost completely destroyed.

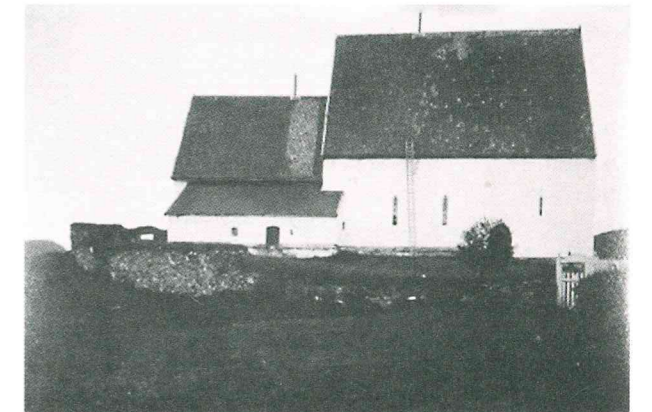
Fig. 10. Trondenes church and the curtain wall seen from the north c.1910. Photographer unknown. Riksantikvaren's Archive, Oslo

The church is built on a small promontory, and the walls stand directly on the rock. The church was surrounded by a still partly preserved curtain wall (Figs. 10-11), which must have covered an area of minimum 60 x 40 m, perhaps more. The best preserved part lies east of the chancel and has three sides. In the corners stand two small towers. Between them the terrain is raised c. 50 cm, perhaps as a sort of battlement. The two towers are entered from this raised area. The walls are 1 m thick, and are today preserved up to a height of 3 m above the churchyard surface.
