CASTELLA MARIS BALTICI 6

THREE CASTLES ON HJELM ISLAND – THEIR MILITARY, POLITICAL AND SOCIAL SIGNIFICANCE

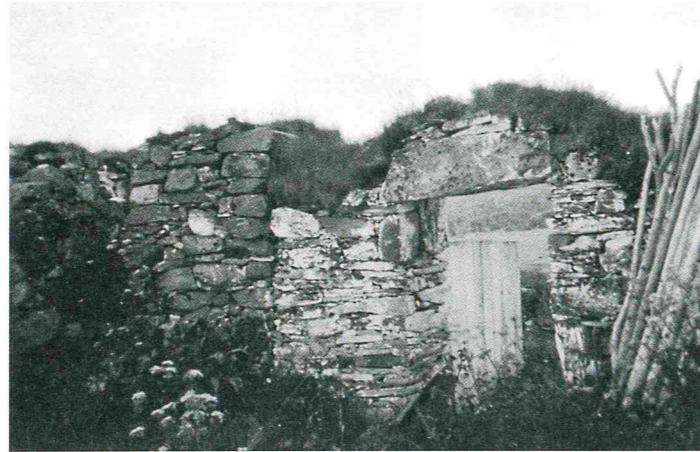
Fig. 12. Trondenes church. The secondary gate between the church and the northern tower, c.1910. Photographer unknown. Riksantikvarens's Archive, Oslo

The northern tower is connected to the church by a secondary wall with a doorway which has no trace of a door. The date of this wall is unknown, but it is probably medieval. It is clearly secondary to the chancel.

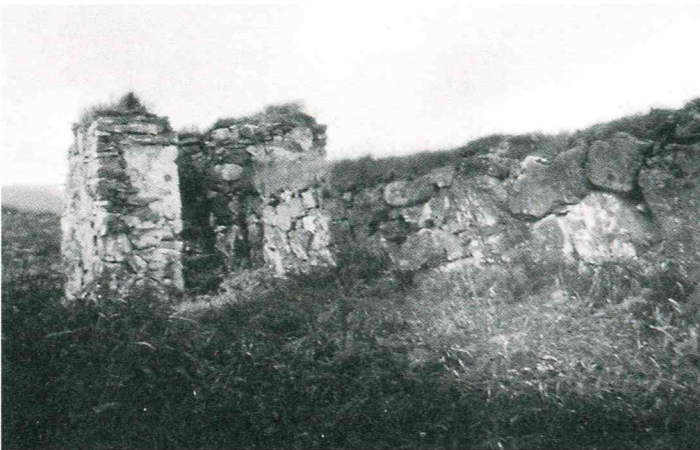
Fig. 13. Trondenes church. The southern tower with its entrance door, looking north, c.1910. Photographer unknown. Riksantikvarens's Archive, Oslo

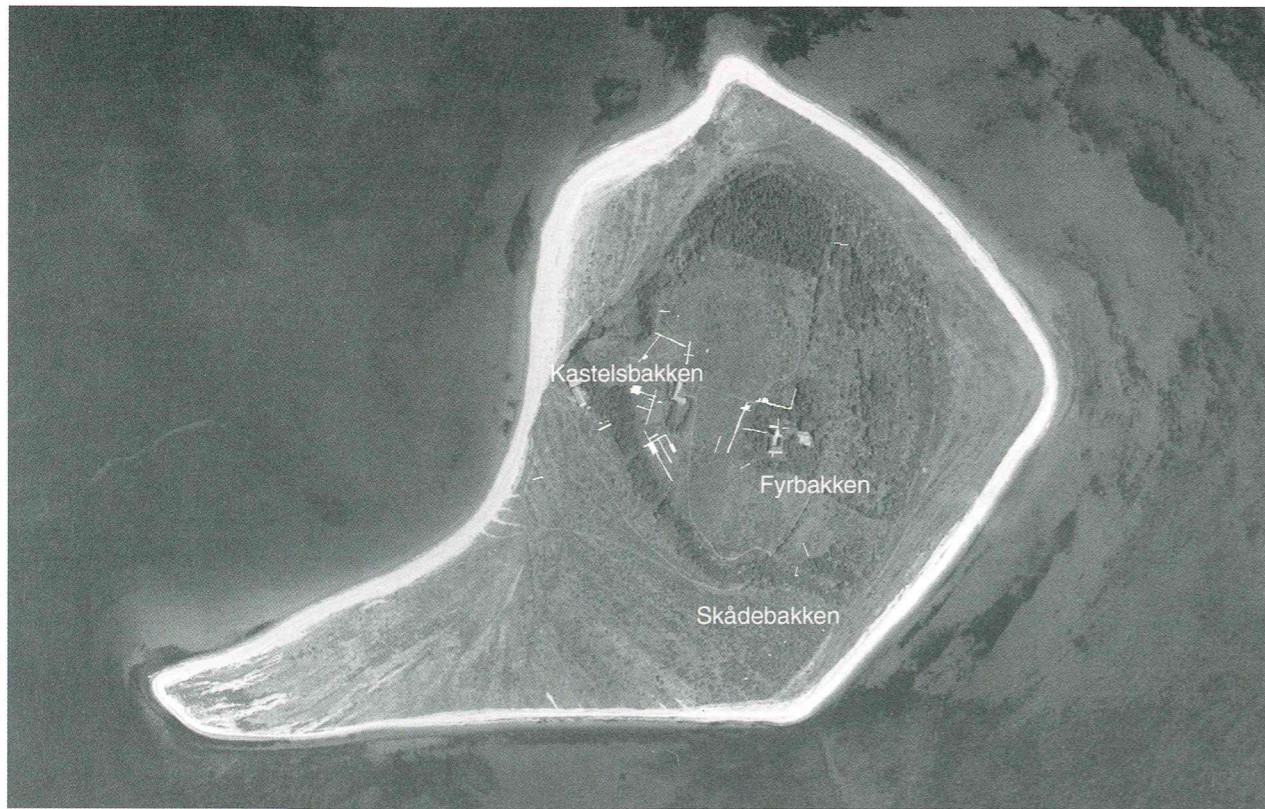
Fig. 3. Trail ditches and excavations-fields on Hjelm 1999 and 2000. Measured by P. E. Skovgaard Jensen, H. C. Clemmesen and C. Dam. Photo: Kampsax

og Johanne Louis-Hansen Foundation it was possible, in 1999 and 2000, to carry out 10 weeks of archaeological investigation with a large team, both on the fortified sites at Fyrbakken and Kastelsbakken, as well as on the open land, where we tried to locate the mint. The research project has been a joint enterprise between Ebeltoft Museum, Moesgaard Museum, the National Museum and the Medieval Archaeology Department at Aarhus University (Fig. 3).

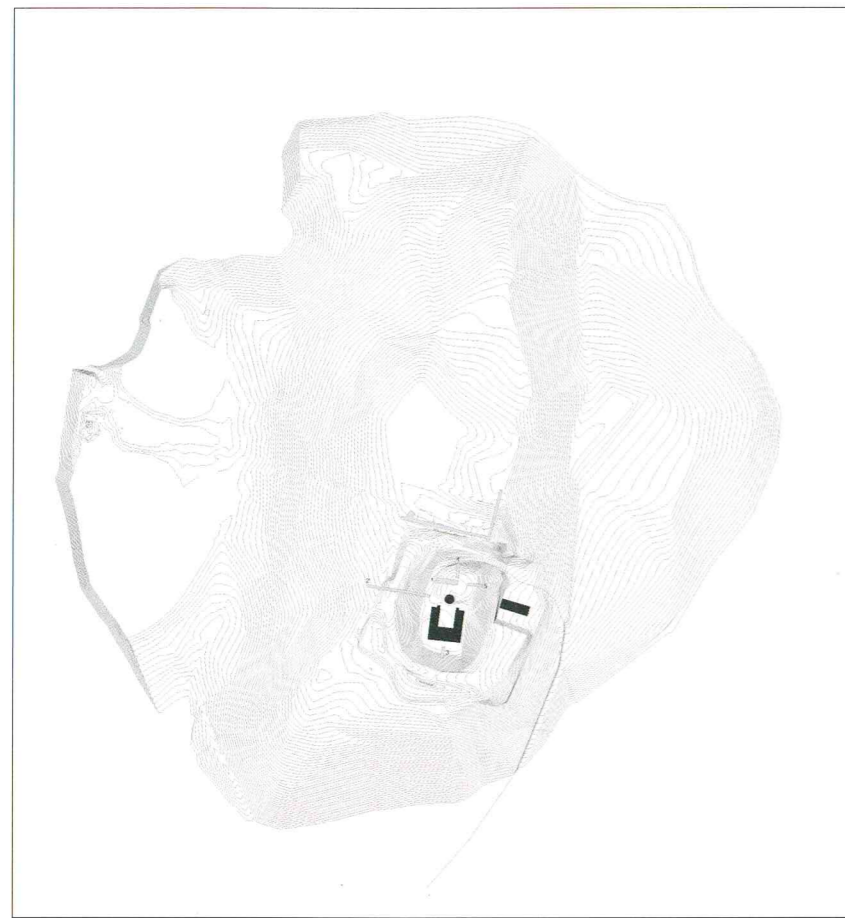
Fig. 5. Fyrbakken with the lighthouse tower, the lighthouse keeper's house and excavation fields 1999-2000. Measured and presented by P. E. Skovgård-Jensen, H. C. Clemmesen and C. Dam

On the very eastern edge of the mound, (Fig. 5), a posthole of more than 1.2 m was recorded. The post was dug 1.4 m down into the clay. The impression of the post itself lay outside the field but the large dimension of the hole shows that the post was a massive one. The fact that the post was placed towards the edge of the mound lends itself to the interpretation that the castle mound was protected - as was confirmed on Kastelsbakken - by a strong palisade along its edge. This interpretation is strengthened by a concentration of iron nails found on field 3 at the southernmost end of the mound. These were found in the burnt stratum dating from the time when the castle was overthrown and can best be explained as nails used to build the palisade.

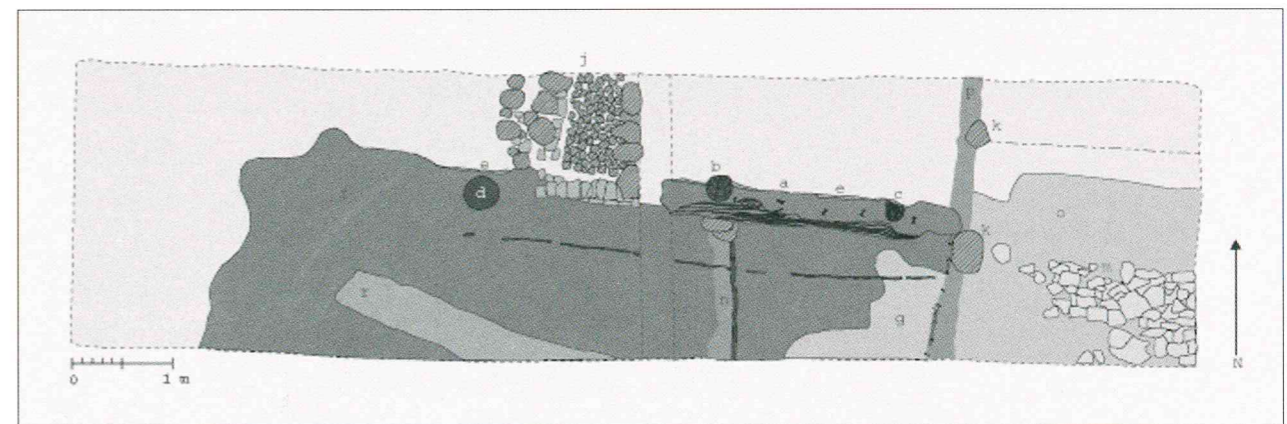
Fig. 6. Fyrbakken, field 1. Remains of parts of the structures, buildings 1 and 2: a: sill; b and c: wall posts; d: post-hole; e: blue clay; f: sunken floor; g: clay floor; h: partition; i: boards taken from the side of a ship; j: oven; k: stones in a stretch of wall; l: plank of a bench; m: collapsed wall built of sun-dried bricks; o: clay floor, building 2; p: wall-trench, building 2; r: ditch excavated 1894. Measured and presented by Pauline Asingh and Louise Hilmar

On the small excavation sites, the remains of three buildings were investigated (Fig. 6). A large building orientated east - west stood on field 1 on the northern part of the hill (building 1). The northern half of it lay within the boundary of the site. Fortunately the site of the building was in a good state of preservation and yielded valuable information that enabled us to observe details of its construction and alterations during the 16 years that it was part of the outlaws' stronghold. The building had several rooms of different construction. In one of them the floor was

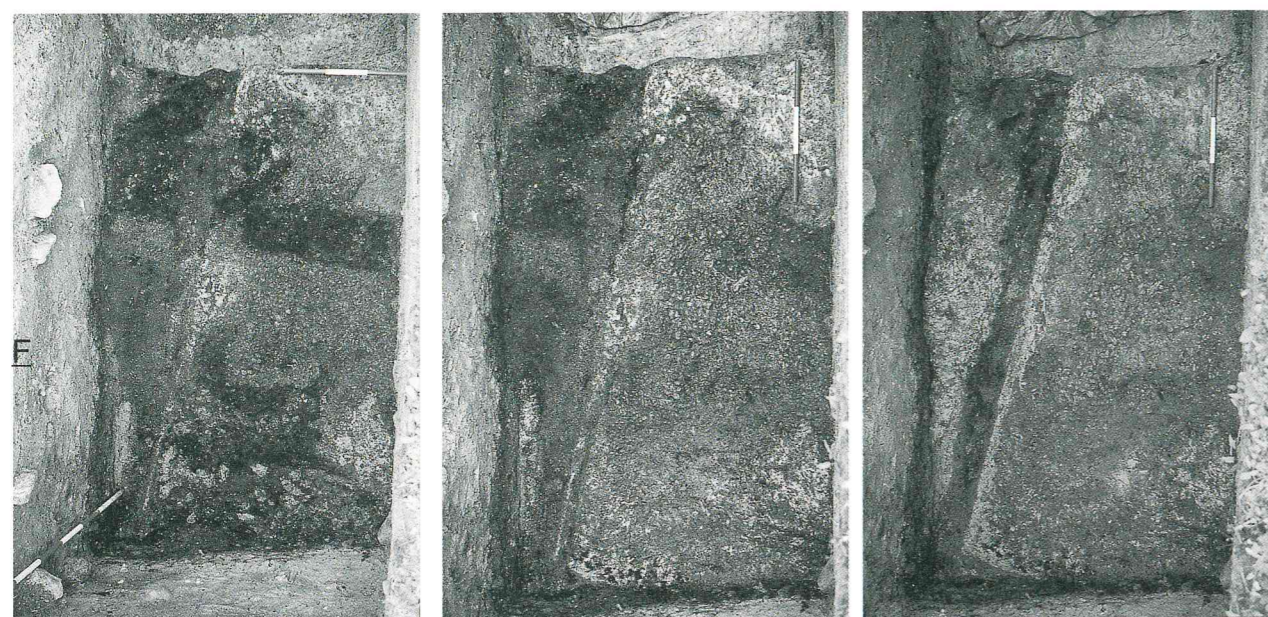
Fig. 7. Fyrbakken, field 4. Building 3 during excavation. Three phases can be seen in the narrow trial ditch: first the collapsed stave-built wall, then the stone-paved floor and lastly the wall-trench with the charred planks. Photo: Per Poulsen

In the ditch, field 4, north of field 1 we succeeded in finding the particularly well preserved part of a house, building 3 (Fig. 7). As on field 1, it appeared under a black layer of charcoal mixed with burnt clay and clay daub, clear sign that the castle had been destroyed by fire. The remains of the house first showed up as a flat area and large pieces of charred wood, the ends of which followed a 20 cm wide

border of reddish brown burnt clay and charcoal. This proved to be a channel about 10 cm wide and 30 cm deep which, taken together with the charred planks on the floor and the charcoal in the channel itself, could only mean that there had been a timber wall here. We succeeded in finding a similar wall at the most southern end of the field. So we had uncovered the south west corner of a building, or rather the south west corner of a room in a building. The rubble on the west of the timber wall can best be explained as belonging to the burned-down building and the wall running north-south should be seen as a partition wall. When the charred planks were removed, a surface of stones the size of walnuts appeared. This was the floor of the house. It was not possible to follow the floor to its full extent northwards, but when the field's sides and floor were cleaned up and measured, it was clear that there had been digging and the same sort of layers of activity as at the time of the castle's inception up to a point which gives building 3 a width of 6 m.

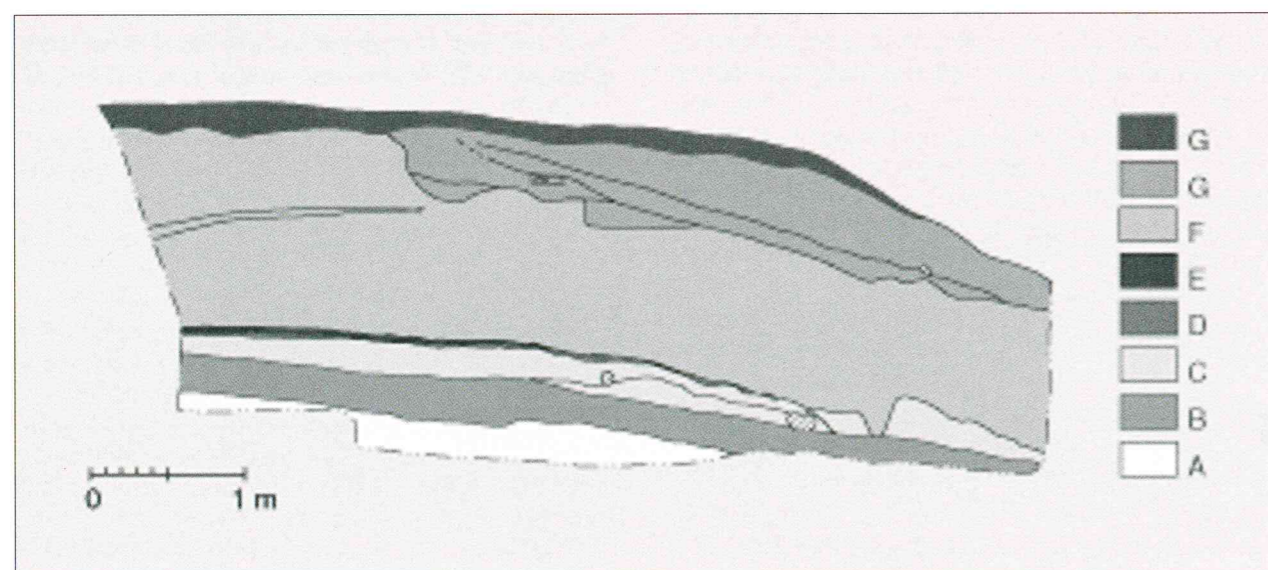
Fig. 8. Fyrbakken, field 3. East profile. A: natural moraine clay deposit; B: vegetation layer; C: construction of the castle-mound; D: from the castle's lifetime; E: formed when the castle burned down; F: the castle-mound raised again after the fire; G: from the time of the lighthouse. Measured and presented by Nils Engberg, Martin Pavon and Sven Kaae

buildings on field 1,3&4 and can only mean that the outlaws' dwellings were destroyed by fire (Fig. 8E). Taken with the written sources' description of how, in 1306, the Danish King Erik Menved took the castles and set fire to them, this can only mean one thing – the layer of burnt material is the result of that. The date is confirmed by the coins and the other finds. With this conquest, Hjelm disappears from the mediaeval written records. It was therefore surprising that a layer of clay about 1.3m thick could be seen on top of the burnt layer (Fig.8F). No finds were made which could date this layer of clay but it was obvious that it was thrown on immediately after the fire. Nothing indicated that anyone had walked on the burnt

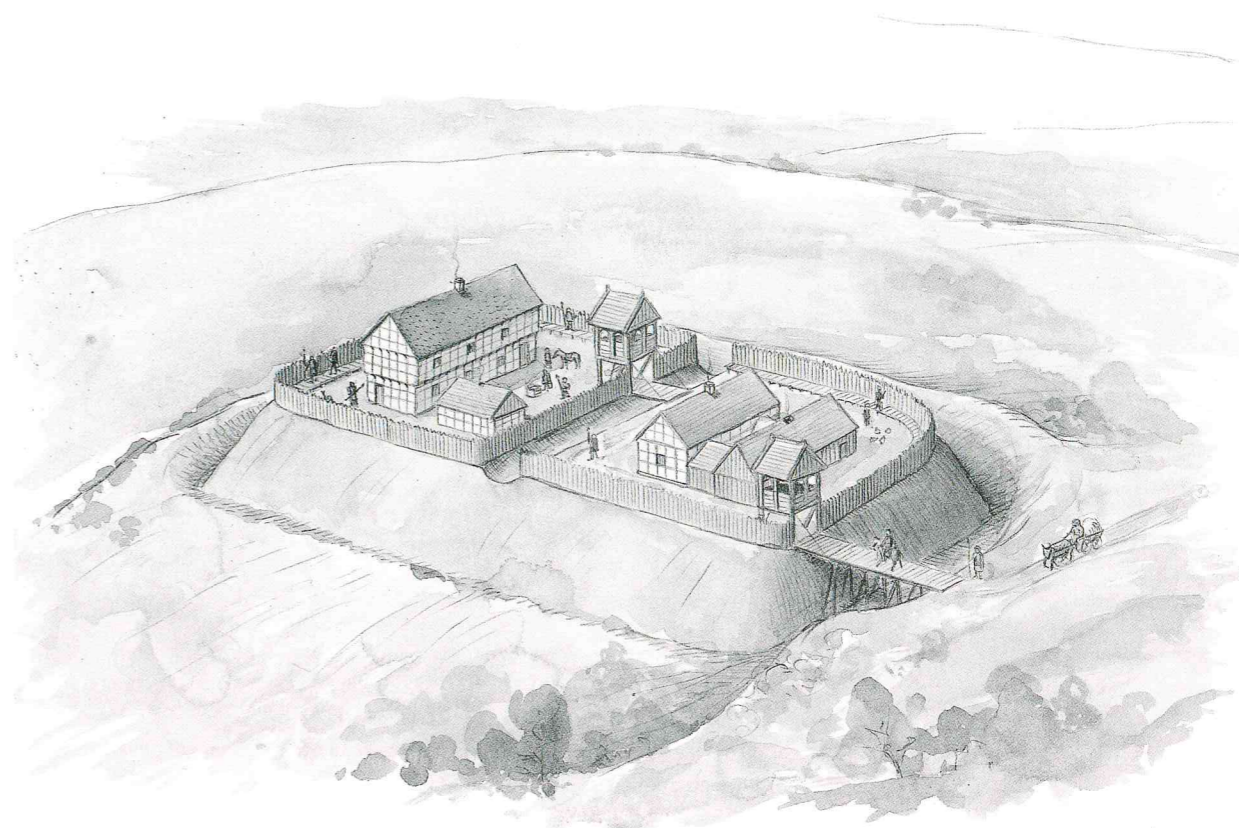
Fig. 9. Reconstruction of the castle at Fyrbakken. Presented by Nils Engberg, Pauline Asingh and Jørgen Mühlmann-Lund

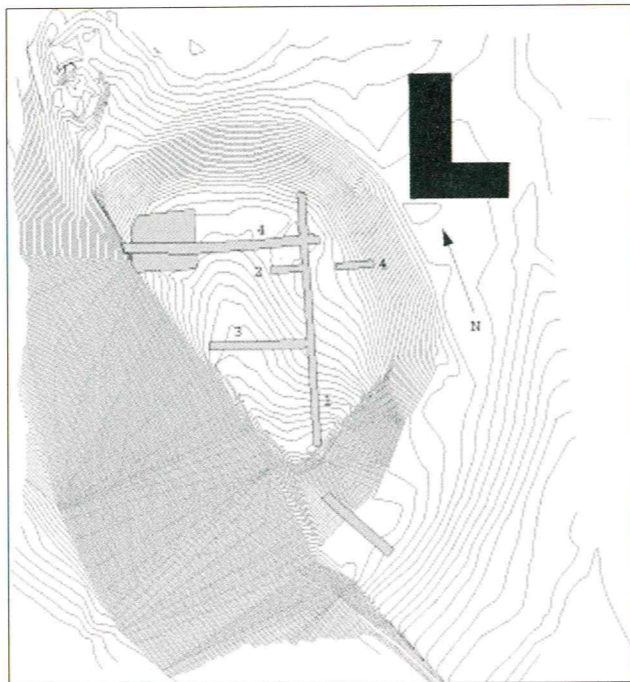
Fig. 10. Kastelsbakken with trial ditches and field of the investigations in 1999 and 2000. Measured and presented by P. E. Skovgård-Jensen, H. C. Clemmesen and C. Dam

A series of trial ditches and an excavation site were laid out (Fig. 10). Access to the castle was not proven by the somewhat limited excavations, but the gateway to Kastelsbakken must have been facing in the direction of Fyrbakken Castle. The moat was not at all impressive, with a maximum depth of 1.25 m and a width of no more than 7 m. The rampart nearest the excavation in the moat consisted of exactly the same layer of gravel which we found under the moat. This clearly indicates that the rampart was constructed from the material dug out from the moat. The moat, because of its shallow depth, was probably dug out primarily to provide material for the building of the rampart on the castle mound.

We found evidence of the rampart in three places on Kastelsbakken. Trial ditch 1, which ran approximately north-south, cut through a layer of added clay which is the remains of the rampart. The base of the rampart was 7 m wide at this point. It was about 3 m higher than the top of Kastelsbakken. On the outside, the rampart material was probably held in place by a palisade, which functioned as a breastwork on top of the rampart.

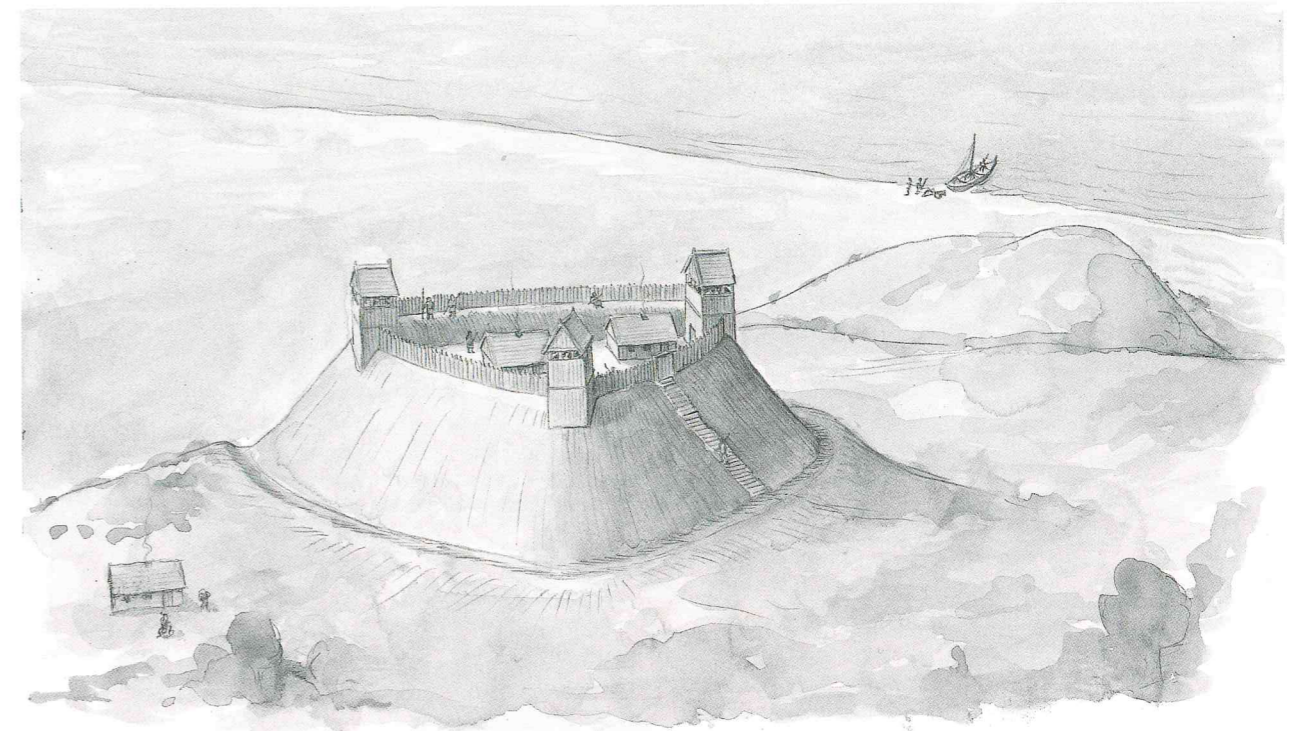
Fig. 13. Reconstruction of the castle at Kastelsbakken, seen from the east. Presented by Hans Skov and Jørgen Mührmann-Lund

The aforementioned rampart, the encircling moat and the wooden tower bear witness to the strong fortification of Kastelsbakken (fig.13). The 18 crossbow bolts and 3 spear-points indicate that the castle was fought over at the time of its defeat in 1306. The wooden part of the castle was burnt to the ground, the rampart was levelled off and down the sides of the mound. The destruction was almost total and Kastelsbakken never again functioned as a stronghold (Skov 2002).

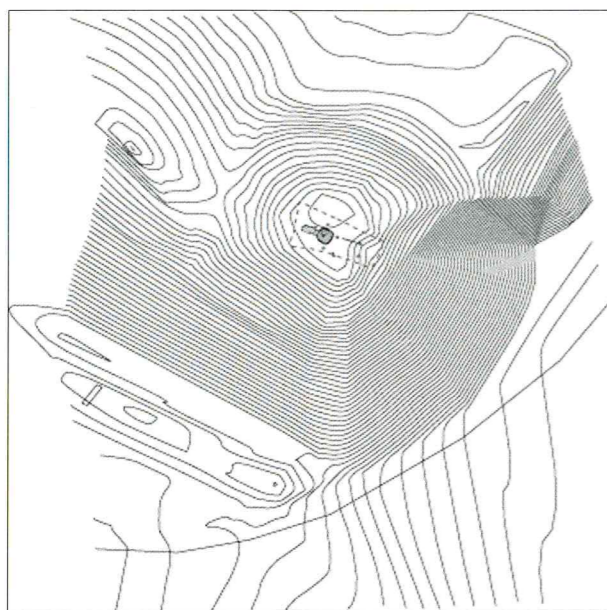
Fig. 15. Skaadebakken. Contour map with the excavation area marked. Measured and presented by N. C. Clemmesen and Louise Hilmar

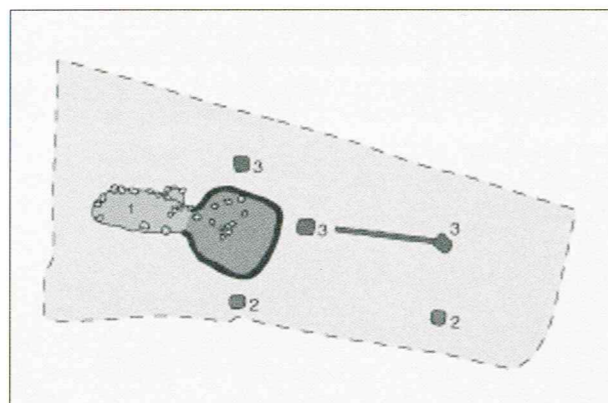
Fig. 16. Skaadebakken. Plan of excavation area, 1952. 1: the “kitchen” with the oven and fireplace; 2: the deep post-holes and 3: the shallower holes. Measured by Hans Stiesdal. Presented by Louise Hilmar

At the dig in 1952, apart from the kitchen area, 5 postholes in all were discovered. They were proven at different depths, just as they were in the new excavations on Kastelsbakken. It was harder or impossible to see in the very mixed up layer of added filling. In 1952 the postholes were categorised in two different groups. Three of them were proven to a depth of 1.5 m. They were square in shape with a diameter of between 15 and 17 cm. In Fig. 15 they are indicated by the Fig. 3. Between two of them lay a strip of clay 10 cm wide and about 2 m long together with a rotted piece of wood with 10 evenly spaced iron rivets in it. A similar construction was dug up on Fyrbakken in 1999 and it was clear that the wood and the rivets had belonged to the side of a boat re-used as part of

Two of the postholes aroused his justified excitement. They appeared suddenly like “an empty hole caused by the earth collapsing”. They were measured with an iron pipe to a depth of almost 3 m. At this point the pipe reached a solid base without it first having to be pushed through loose filling. It was from this observation that at that time it was judged that the filling on the castle mound was about 3 m deep, whereas we can say today, as already mentioned, it must be more modest, just 1.5–2 m, because the posts were sunk 1–1.5 m into the morainal hill. There was not the slightest indication that the posts had been burnt, on the contrary it is quite certain that they rotted away in the holes because the imprint of bark was found in the corners. The observations do not of course exclude the possibility that that part of the posts that stood above ground may have been burnt. The posts were hewn on four sides but as they were not cut very exactly it must have been whole, probably young trees that were used. No wood was left in any of the postholes examined so far, so the types of tree that were used cannot unfortunately be determined. The traces of post show that the dimensions of one post were 21x23 cm and the other 22x22 cm. There is no doubt that these two posts buried so deeply were part of a tower-like construction. There is no longer any doubt either that the building constructions that were found on Skaadebakken have so many similarities to those we dug up on the other two mounds, that they were part of the defences that were built when the Norwegian king and the outlaws fortified the island in 1290.

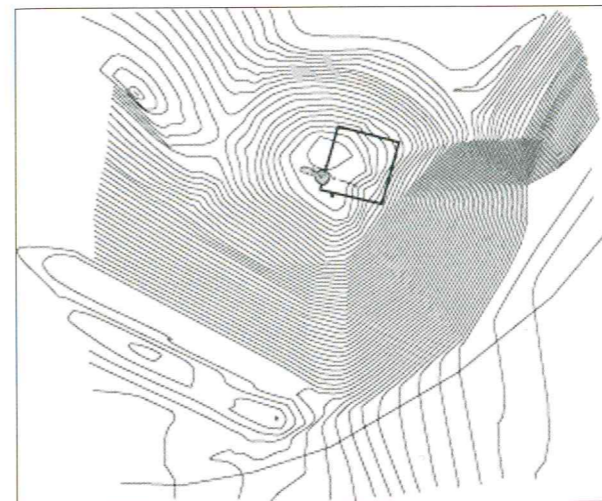
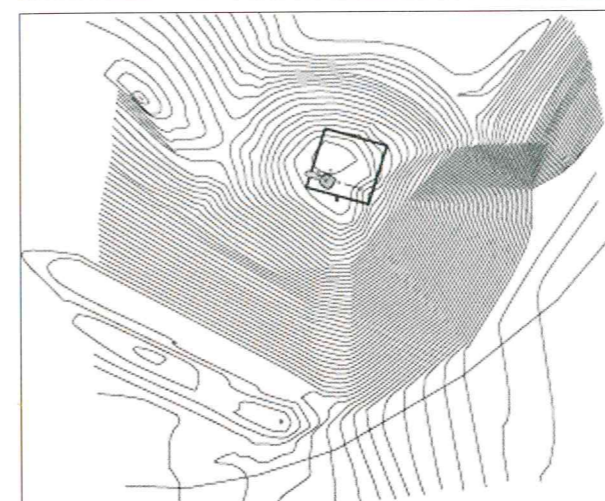
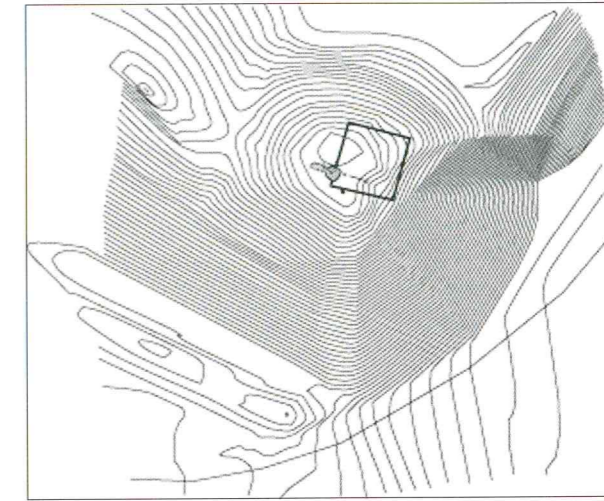
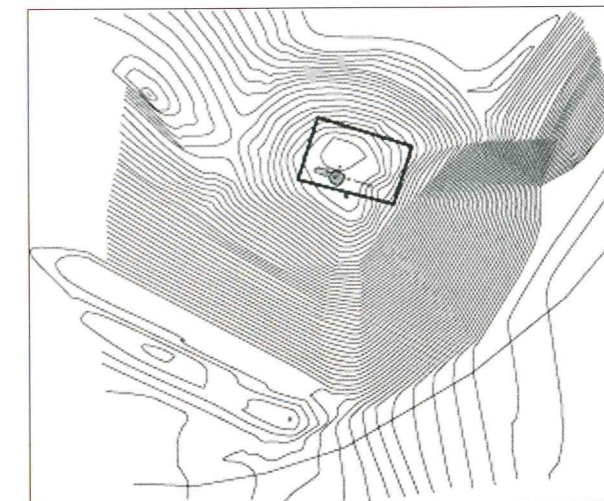
Fig. 17. Skaadebakken. Contour map with indications of possible ground-plans of the tower/tower house. Presented by Nils Engberg and Louise Hilmar

On this modest castle mound there is in fact room for a slightly larger ground plan than that described above. Five posts on each side would give a side

length of 6.4 m. This gives two further possible locations, again using the two known postholes as starting point. Either one location out on the eastern side or one more central. The eastern location would have a wall out over what is today the mound's eastern slope, but that is reasonable, because it is here that the sea has eroded part of the castle mound and caused it to collapse. As can be seen in Figs. 17b-c, both these locations would give buildings with a west wall standing diagonally across the kitchen, so this suggestion is not likely either. There remains one last possibility: this posits a building that covers the whole of the mound (Fig. 17 d). With this solution we estimate that there was room inside the building for a kitchen and this does not mean that there were postholes, which were difficult or impossible to find in 1952. In the building there were therefore 3.2 m between the wall-posts. But two more on each of the long sides, give the building a total length of 9.6 m and its width could scarcely have been more than 6.4 m (Fig. 18). This is a size that is well-known from the stone houses in mediaeval castles, which, with the addition of three or more storeys are called “tower-houses” in English.

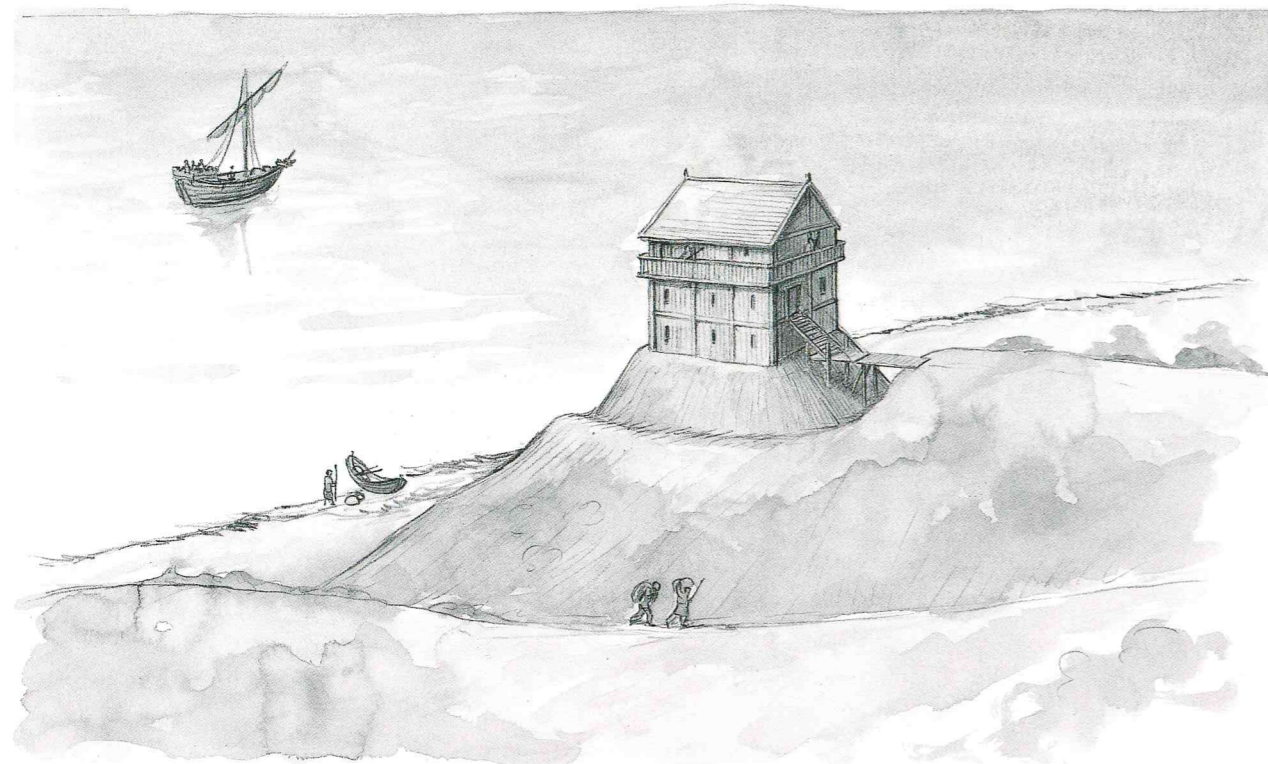
Fig. 18. Reconstruction of the castle Skaadebakken. This is based on the assumption that on the small castle-mound there was a tower house with three storeys, with access across the moat in the form of a small drawbridge and a staircase that led to the entrance on the 2nd floor. Presented by Nils Engberg and Jørgen Mührmann-Lund

For those leaving the castle, we may imagine that there was narrow drawbridge over the moat. It was not necessary to take horses or carts to the castle, so the bridge was exclusively for pedestrians who were led over to the building's west gable where we assume steps led up to the second storey entrance. There is not much to be said about the interior of the tower. The kitchen, as we have seen, was on the lowest floor and had a small floor space with an oven and a hearth. Part of the assumed run of a wall is not enough for us to guess the layout of the rooms. But the fact that the side of a boat was found to be part of a wall shows that the fortifications on Skaadebakken too were erected in great haste, using all the materials to hand.

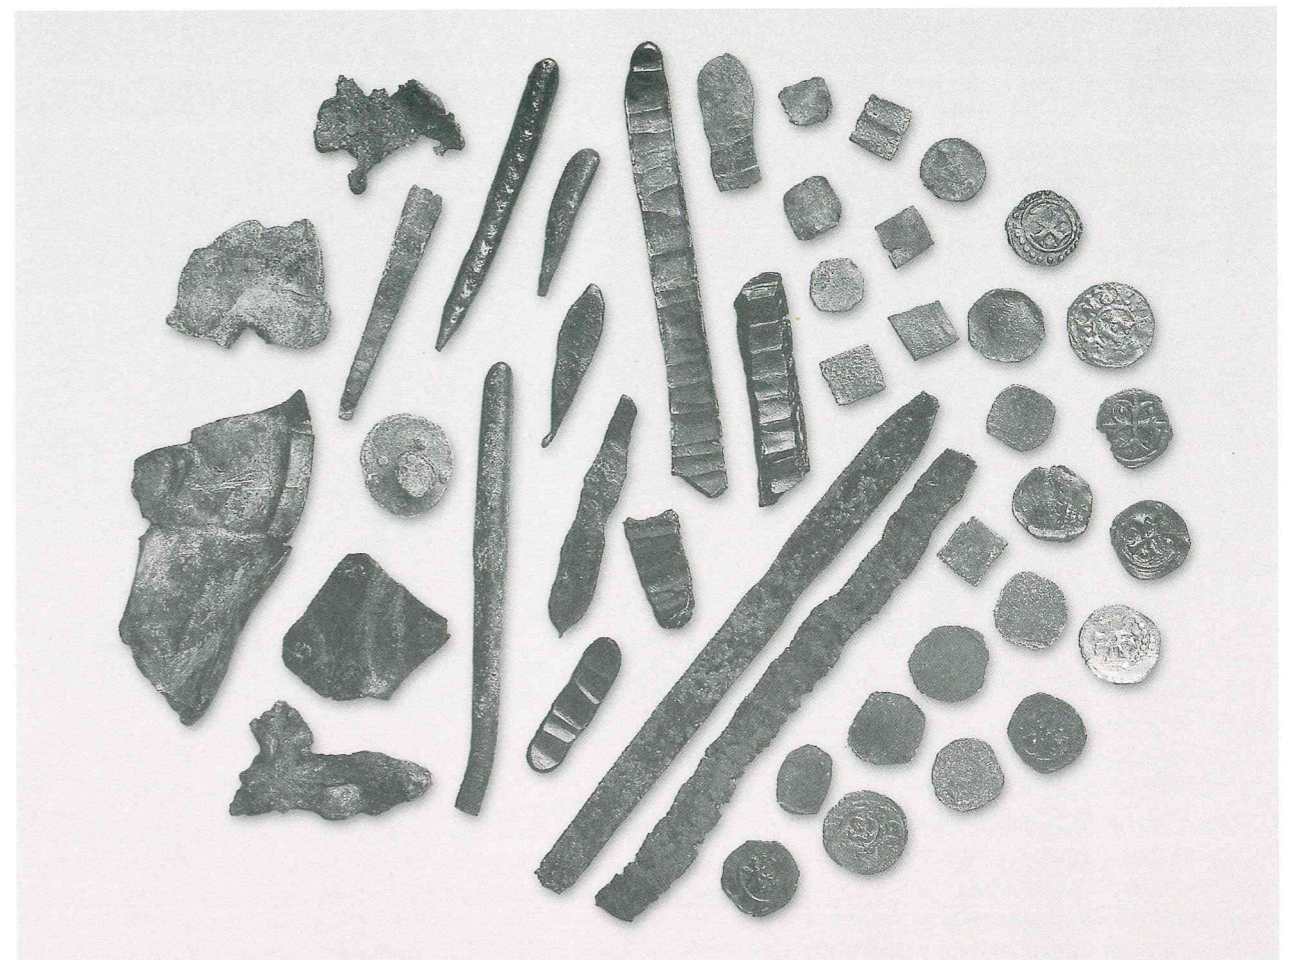
Fig. 19. Copper-waste, bars and blanks in various stages of presentation, together with complete coins. Photo: Tove Pedersen

and layers of 5–10 cm at a time were excavated. In all, more than 2000 coins, blanks, ingots and pieces of scrap copper were found as well as melted copper and slag (Fig.19). There were particularly large concentrations in three places. These were in the place known locally as the Mint (77 coins 467 blanks, and 80 ingots), a dip in the ground north of Kastelsbakken (106 coins, 253 blanks and 48 ingots) and close to the moat north-west of Fyrbakken (7 coins, 23 blanks and 6 ingots). We think that we have uncovered the western part of an actual coin workshop, with wall ditches, postholes for posts where the lower die was situated, three partly buried barrels and a forge (Fig. 20). The ground plan is very similar to that excavated in the archbishop's mint in Trondheim. North of Kastelsbakken, the remains of a building that must have housed another coin workshop was found. Meanwhile, at "the Mint", no remains of buildings were found, having been ploughed under. There is no doubt that coin production had gone on in these places. The large quantities of copper found, represent all stages of manufacture – copper-waste, waste from castings, newly cast and hammered-out bars, cut-out blanks which were cold-hammered further to make round blanks, as well as finished coins. Bars had also been cut directly from copper pots and blanks made from

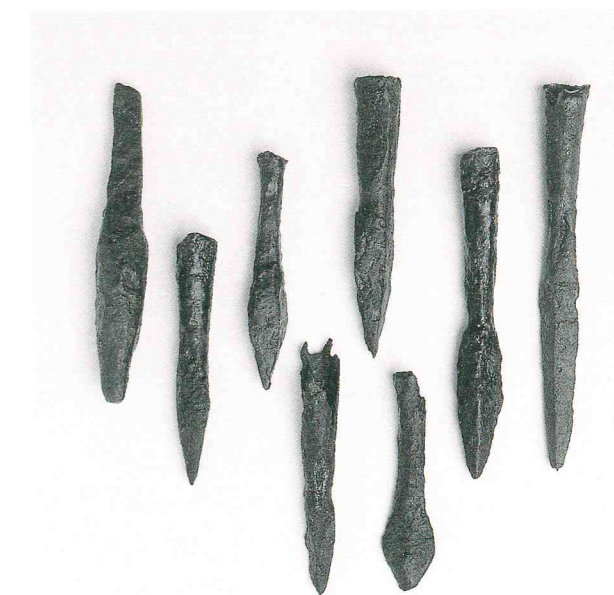
Fig. 22. Crossbow arrowheads found at Kastelsbakken. Drawing: Louise Hilmar

Kastelsbakken. The finds of 18 crossbow bolts and three spear-points show that they had to fight to take the castle (Fig. 22).
