CASTELLA MARIS BALTICI 6

Henriette Rensbro

STEGE CASTLE 1314 AD - A DANISH WOODEN CASTLE ?

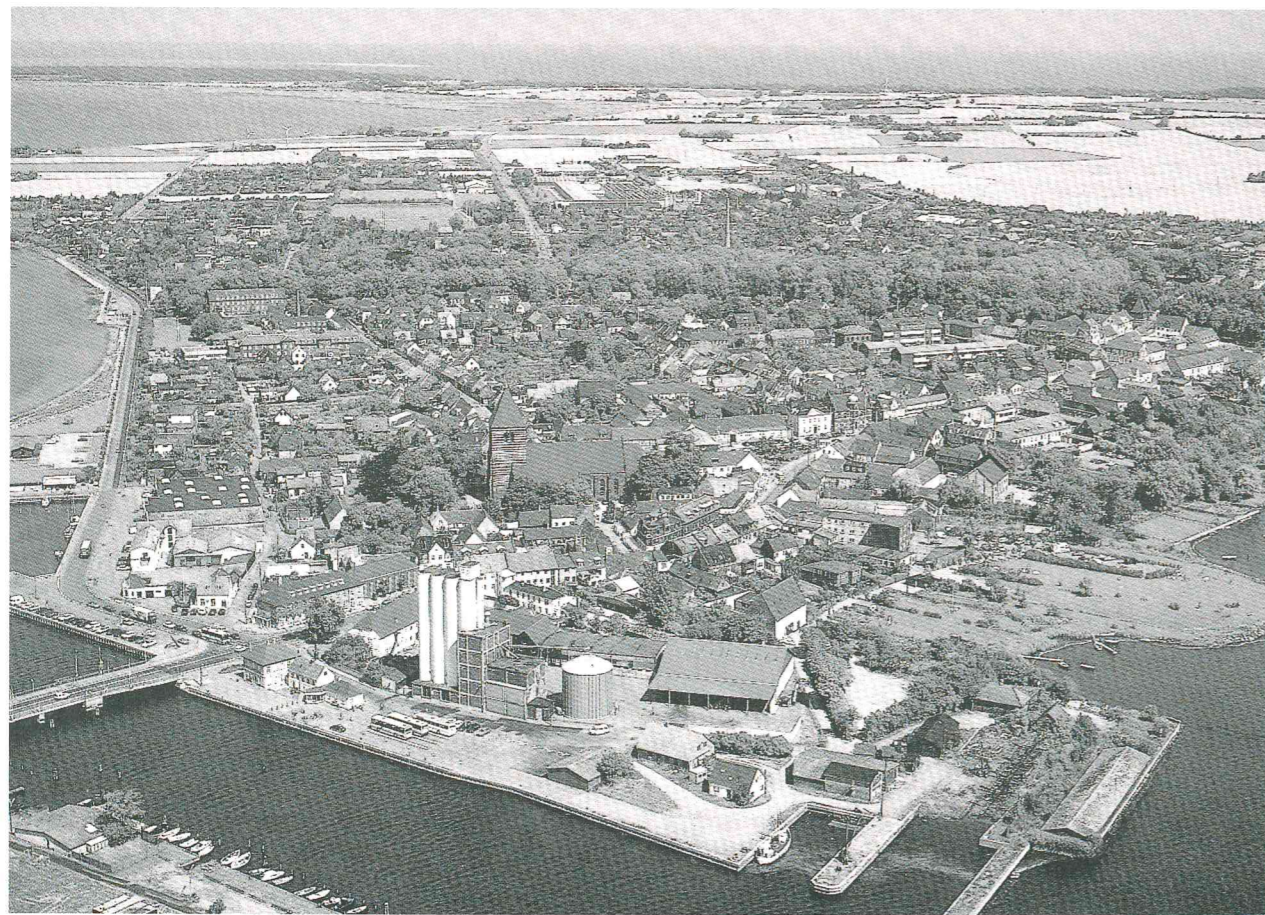
Fig. 1. Aerial view of Stege town, from the south. In the foreground are the silo warehouses built on top of Stege castle. The silos were demolished before the excavation in summer 2000. Postcard

Stege town of today is a small provincial town with a well preserved medieval town plan (Figs. 1,2), an early 13th-century church and a late 15th century defence wall. Stege castle though was demolished centuries ago and the exact place of the castle was forgotten until 1976 when a small archaeological excavation revealed the castle's entrance gate (Fig. 6) (Bekmose, Nielsen 1978).

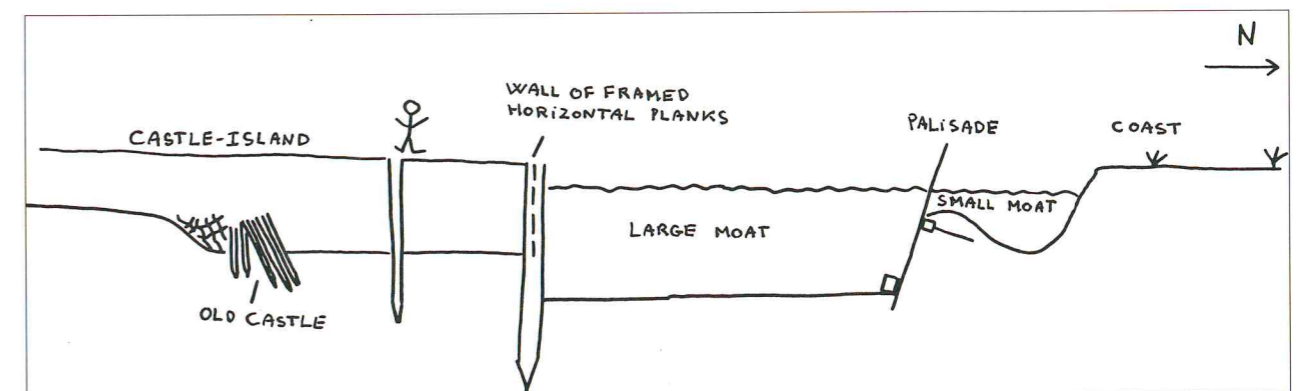
Fig. 3. Sectional view of castle-island and moats from the east. To the left are the original island and the row of piles, which hold the artificial island of the old castle. The rest of the structures belong to the 1314 Stege Castle. In the left side of the large moat is the wall of framed horizontal planks. In the right side is the small moat behind the palisade

The castle built in 1314 has a predecessor which is briefly referred to in written sources and registered during the archaeological excavations. Very little is known of this castle. It dates back to early 13th century or even before and was situated on the same site south of Stege town. The artificial island though was much lighter supported than the 1314 castle. One of the excavated wells most likely belongs to the old castle. (fig.3)

abrupt slope of earth and clay created when digging the large moat (Figs. 7,8). At the bottom of the moat the planks are fixed by beech beams (5–7 meters long and 0,40x0,40 meters thick), which are hold to the bottom by beech pegs (0,50 meters long) (Fig. 8). A necessary fixation at a higher level of the planks is not preserved. At the top of what is preserved are, behind the planks, oak beams (5–7 meters long and 0,25x0,25 meters thick) which the planks rest onto and which are fixed to the earth and clay slope by (1 meter long) oak pegs (Fig. 3). The original height of the palisade is not known, but it is known that, at the top, the planks

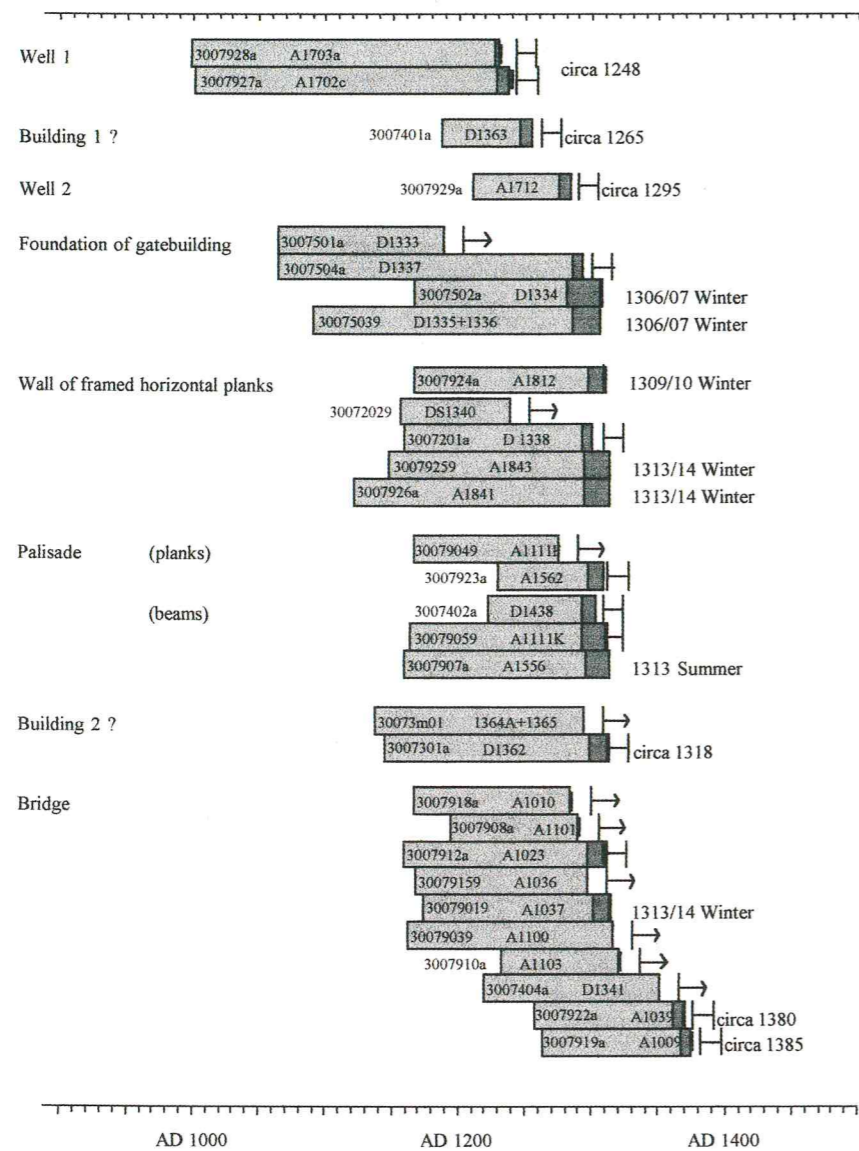
Fig. 4. Dendrochronological datings of timber from Stege castle, by Aoife Daly, NNU Copenhagen (Daly 2001). Buildings 1-2 and foundation of gate building were excavated in 1976-77 (Bekmose, Nielsen 1978).

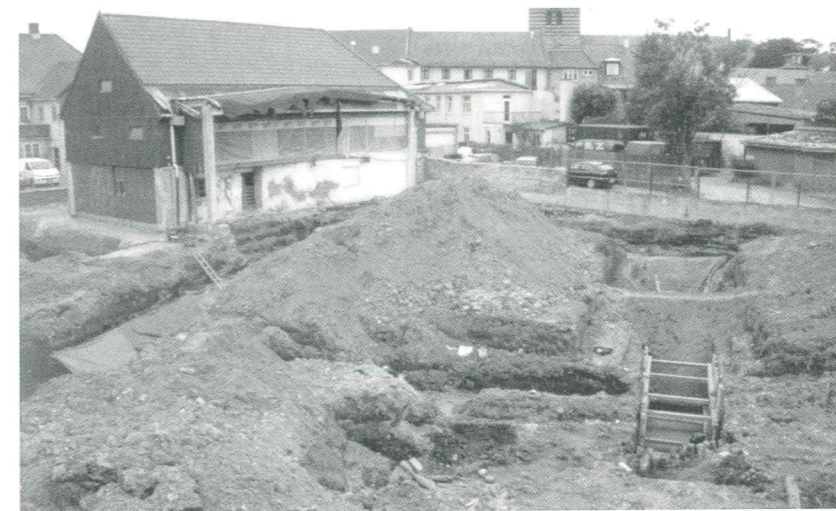
Fig. 5. The palisade from the south-east. The palisade forms an angle to the north and west side of the castle-island. The corner is in the central part of the picture. The northern palisade is partly hidden by large piles of earth

As regards all of Stege Borg the wooden palisade is preserved up to modern water level. The palisade forms an angle to the north and west side of the castle-island. It is situated at the farthest side of the large moat (Fig. 5). The palisade consists of vertical oak planks, up to 3,50 meters long and 0,45–0,70 meters broad. The planks lean by 15° backwards to the

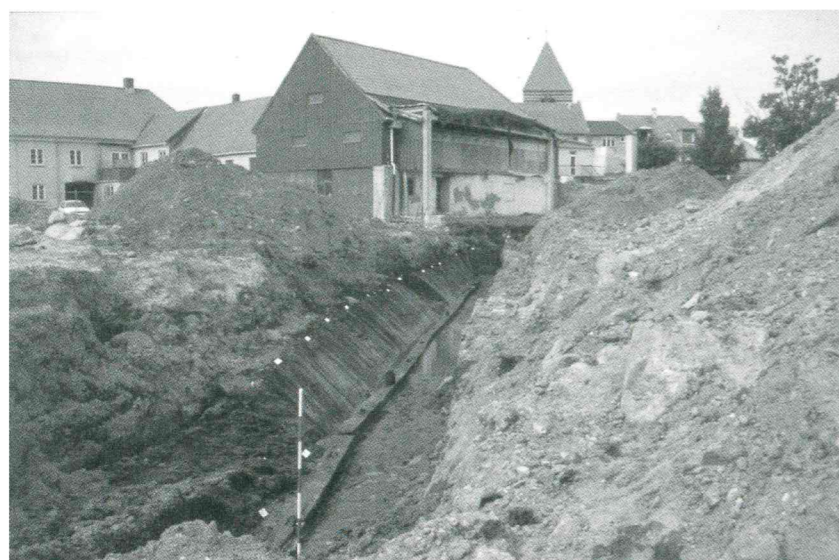
Fig. 7. The western part of the Palisade, from the south. As regards all of Stege Borg the wooden palisade is preserved up to modern water level. Above this level is more than 1 meter of modern, disturbed layers. In the background is the tower of Stege church

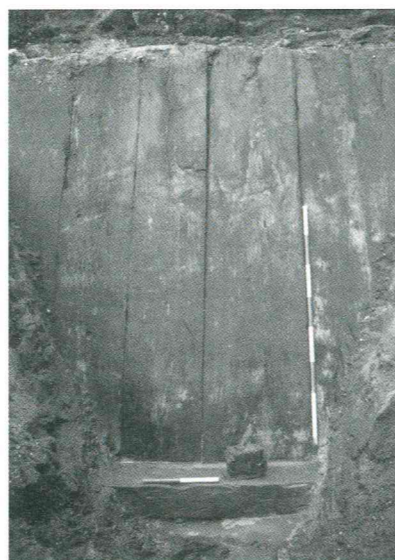
Fig. 8. The northern part of the palisade from the south. At the bottom of the moat is the beech beam, which holds the planks

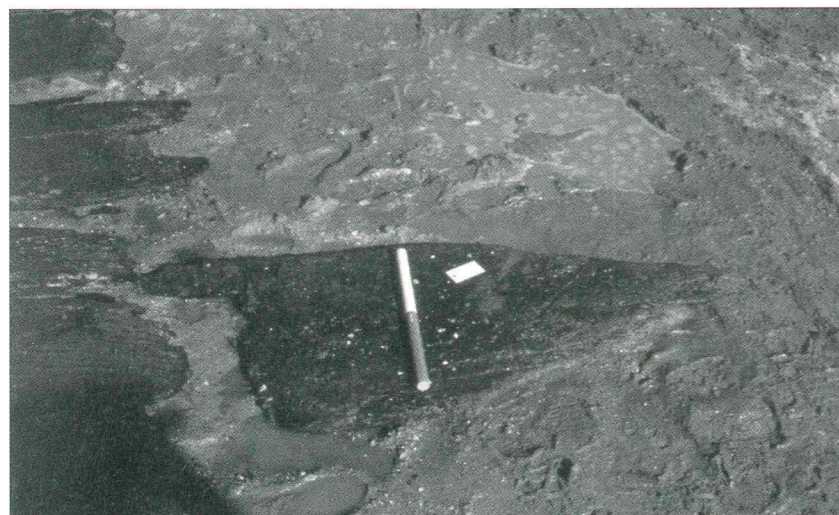
Fig. 9. Tapered top of a palisade plank found in the bottom of the large moat

were tapered, so as a general impression the palisade was jagged (Fig. 9).

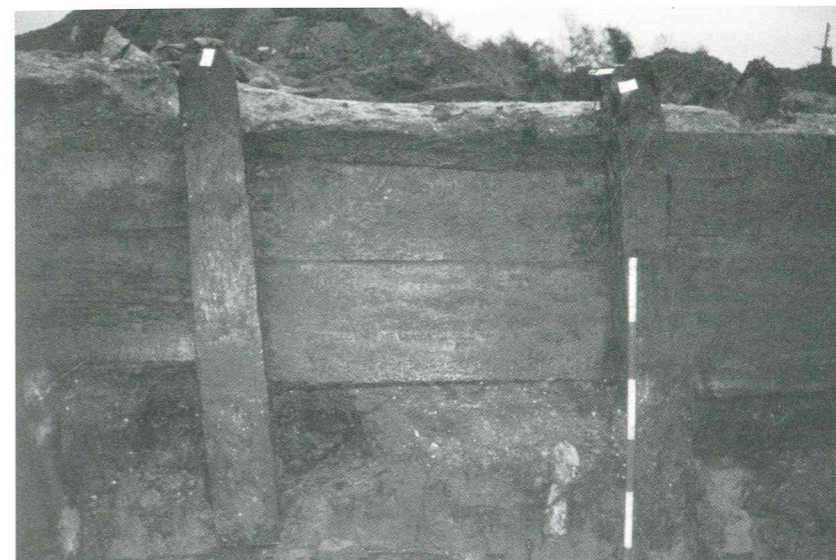
Fig. 10. Wall of framed horizontal planks surrounding the artificial castle-island

The castle-island was enlarged with material from the deepening of the large moat, mainly clay. To hold the clay from slipping into the moat a wall of framed horizontal planks surround the island (Fig. 10). The wall

consists of vertical oak posts (0,20x0,35 meters thick) pointed and hammered into the seabed and of horizontal oak planks (0,9–1,30 meters long and 0,30–0,60 meters broad). The planks are joined in rabbets cut in the posts. It is not known whether this wall originally rose above the water level.

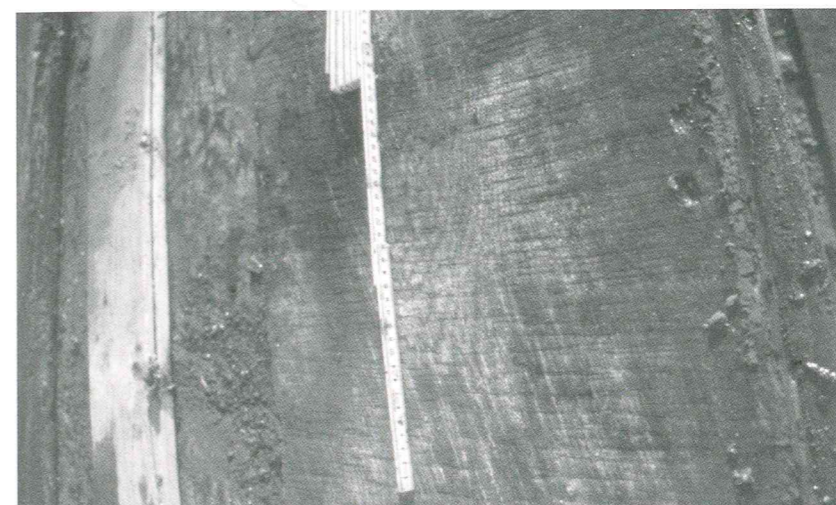
Fig. 11. Oak plank showing saw marks. Saws were used to cut out all planks from Stege Castle and the edges are cut to shape with an axe

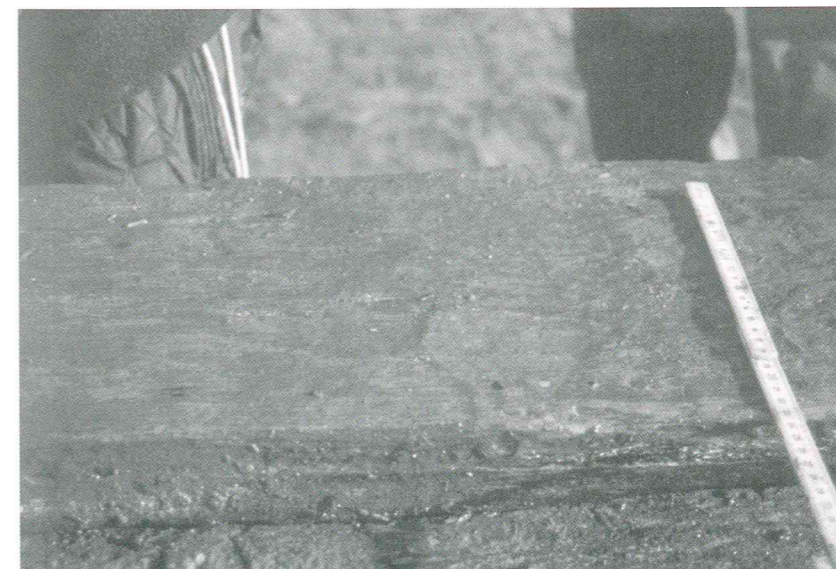
Fig. 12. Beech beam showing axe marks. Most of the beams from Stege castle are cut with axes on two sides and with saw on the other two sides
