VYTAUTAS KUGEVIČIUS

### KOMPAKTIŠKO PLANO PORINIŲ NAMŲ RESTAURAVIMO YPATUMAI (XVI—XVIII a. ARCHITEKTŪROS PAMINKLO, GYVENAMOJO NAMO KAUNE, T. DAUGIRDO G. 4, PAVYZDŽIU)

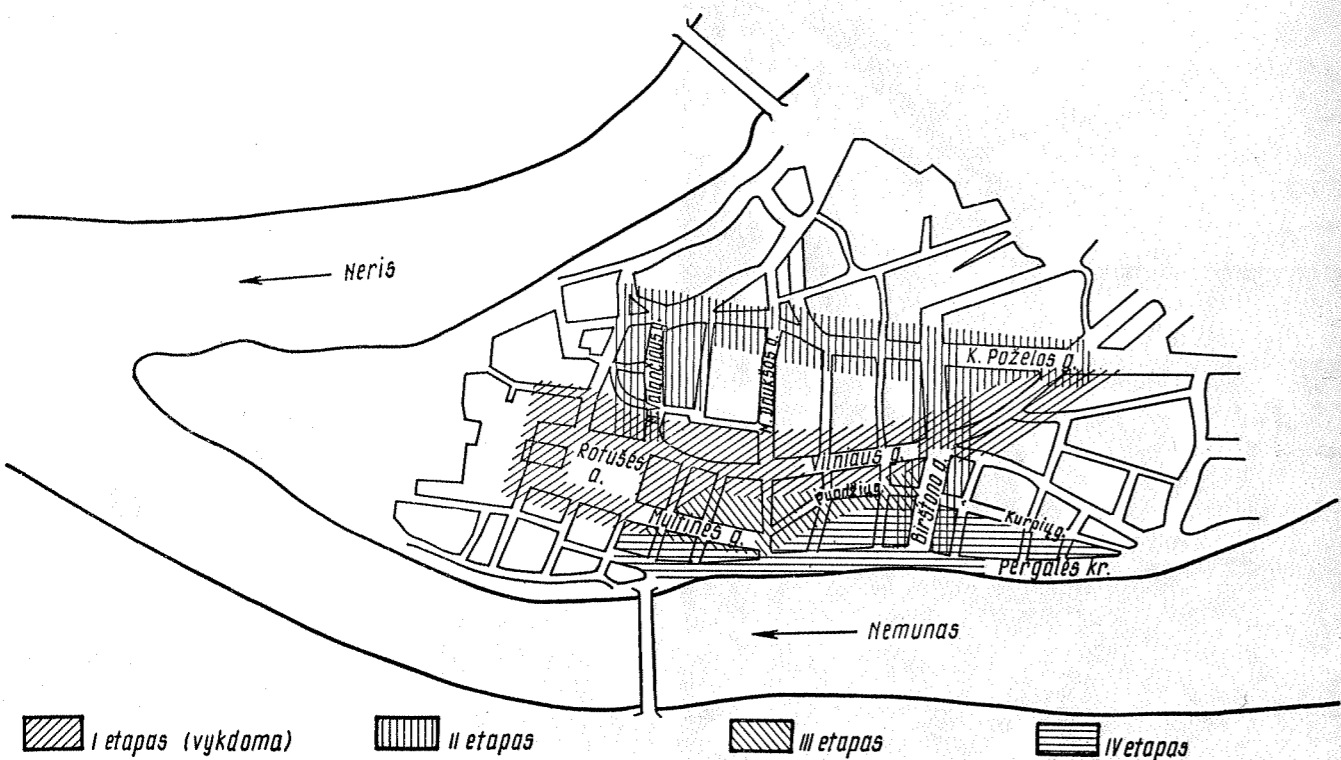
48 pav. Kauno senamiesčio regeneracijos „juostiniu“ metodu schema

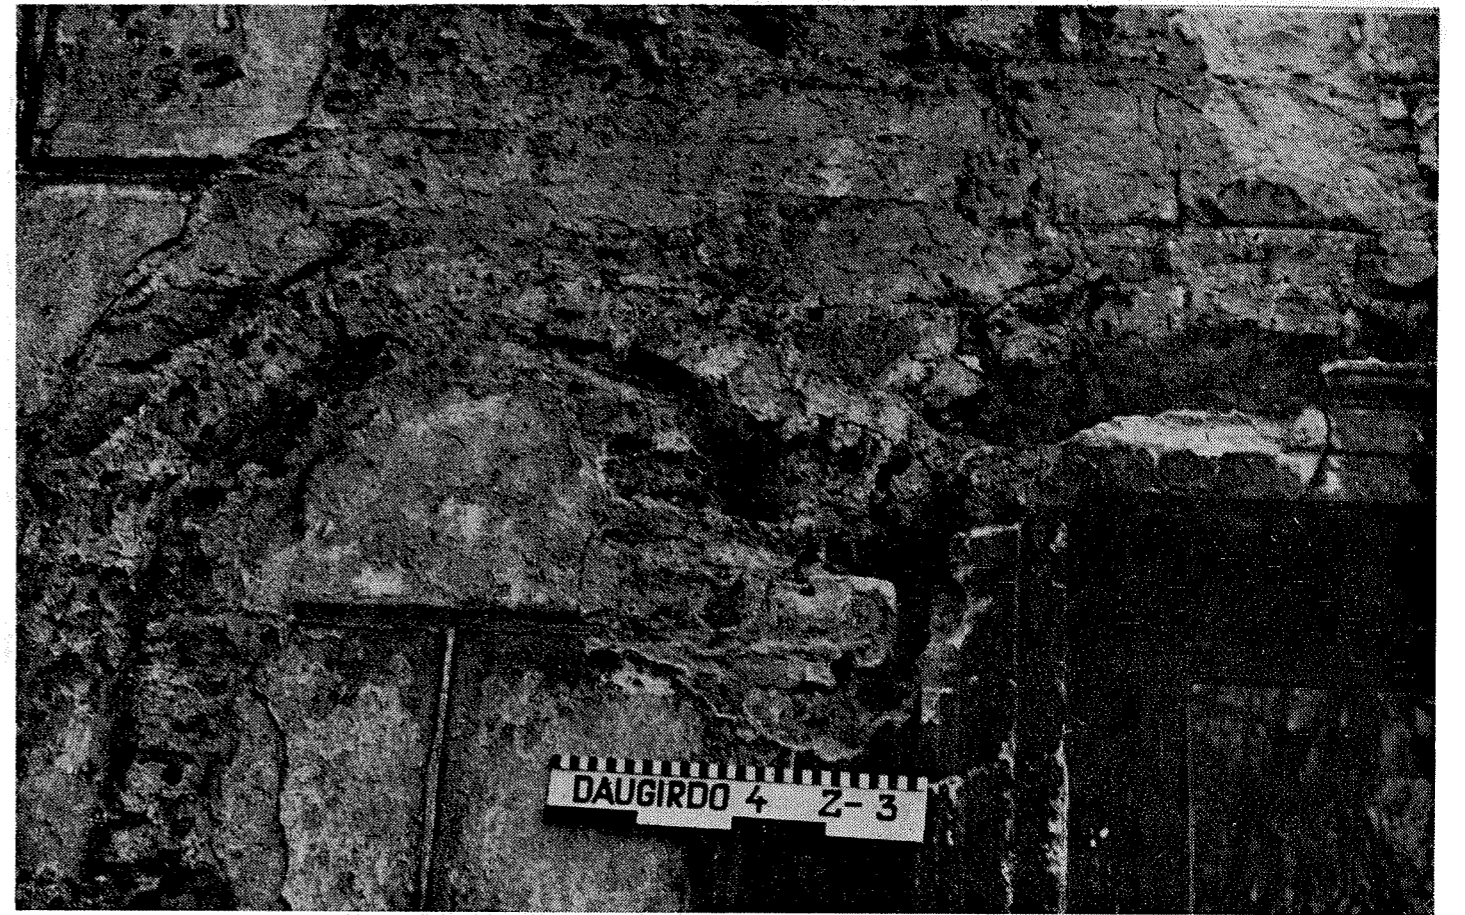
2 pav. Siaurinio namo pagrindinio fasado pirmojo aukšto zondažas: langų nišos su dvigubomis segmentinėmis sąramomis, suremtomis į konsolinę plytą-spyną

Siaurinio namo pagrindiniame fasade yra gotikinio mūro fragmentų su neblogai išlikusiu paviršiumi, pakankamai aiškiai atskleidžiančiu pirminių plytų dėjimo būdą, siūles, sąramas. Du antrojo aukšto langai perdengti segmentinėmis sąramomis, o pirmojo aukšto langų angos įterptos į retai pasitaikančias, puošnias nišas su dviem segmentinėmis sąramomis, suremtomis į konsolinę plytą (2 pav.). Šis komponentas būdingas vėlyvosios gotikos vienuoliams. Atskleista ir durų angos kontūras su įstrižai nusklemtų plytų apvadu. Apie visų penkių angų mūrinių ir medinių sąramų jungtis kol kas galima tik spėlioti. Tikriausiai visų angų staktų viršus būvęs tiesus, nes durų ir antrojo aukšto angų segmentai lėkšti, o analogijos rodo, kad tuo atveju rėmas nebuvo lenktas. Po dvigubomis segmentinėmis mūro sąramomis, kurios buvo ir dekoratyvinis ir nukrovimo elementas, virš lango tikriausiai būta rąstų sąramelių. Durų anga nesutampa su fasado simetrijos ašimi, langai taip pat išdėstyti laisvai, nors pirmas įspūdis toks, kad šis siauras fasadas simetriškas. Šį įspūdį sustiprina dekoratyvinė nišėlė tarp antrojo aukšto langų (4 pav.). Virš abiejų aukštų langų — paprasto profilio tinkuotos frizinės juostos. Aukščiau viršutinės juostos dar yra to paties laikotarpio mūro. Tai pagrindžia prielaidą, jog namas turėjo

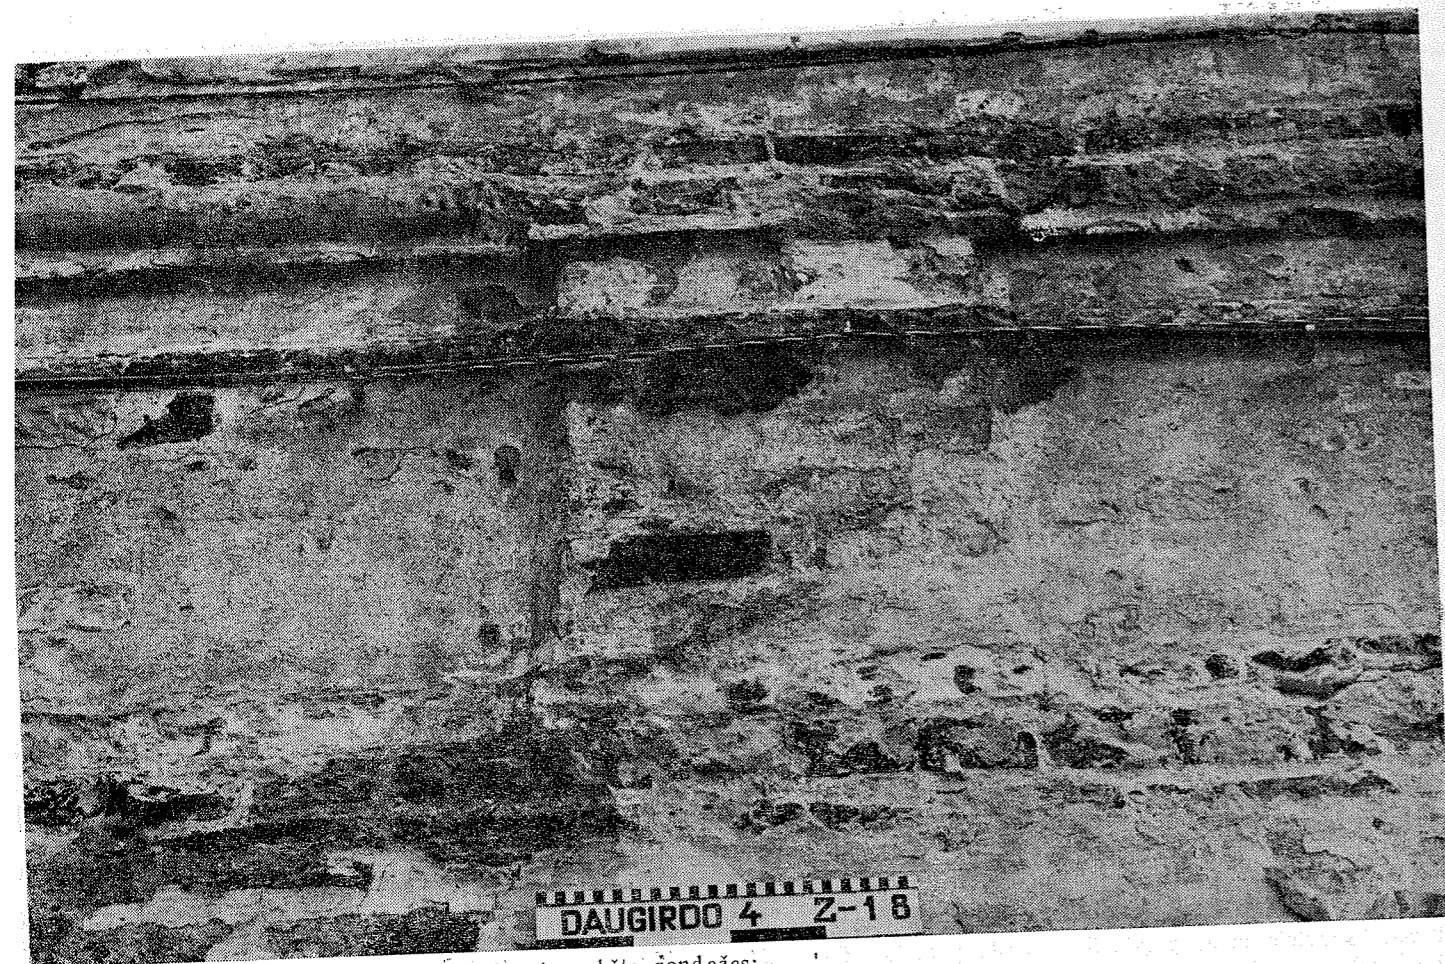
3 pav. Pietinio namo pagrindinio fasado pirmojo aukšto žondužas: 1770 metais suformuota tarpaukštinė frizinė juosta, kurios profiliui naudotos plonos plytelės

Vienas ryškiausių šio fasado komponentų — 1,10 m pločio tarpaukštinė frizinė juosta (3 pav.). Ją sudaro trys grupės profilių, kurių siaurųjų dalių reljefui naudojamos plonos keraminės plytelės. Beveik simetrijos ašyje ir prie namo kampų visu juostos pločiu iškyla pilastrų dalys. Jų reljefas tik kelių centimetrų, o tęsinio žemiau frizo nebėra. Virš ant-

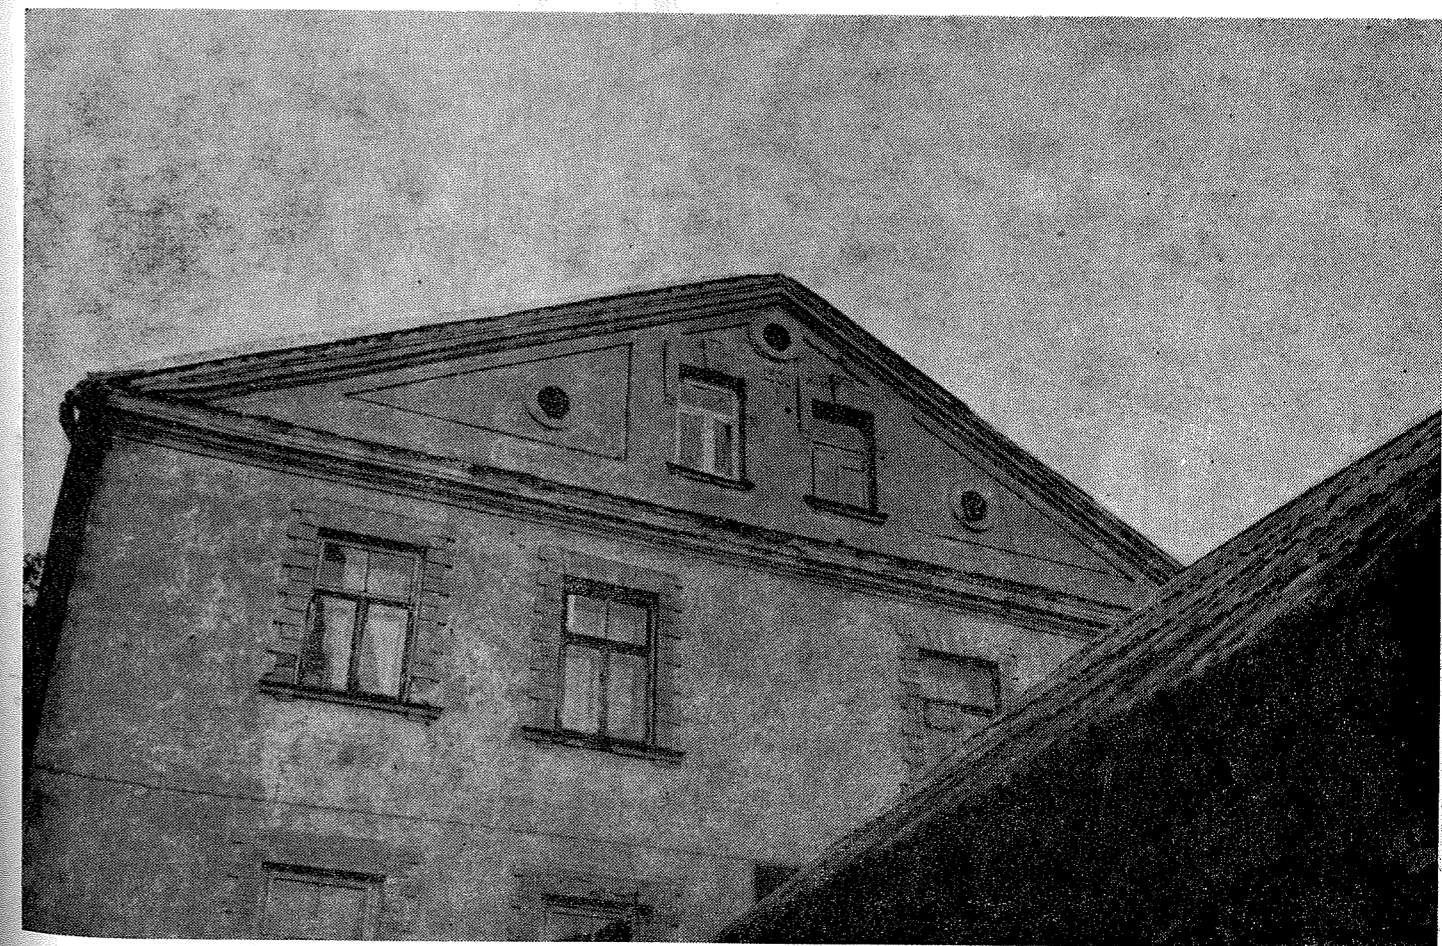
5 pav. 1906 m. rekonstrukcijos baigiamasis „akcentas“ — timpanas iš rytų pusės

Namas buvo baigtas gadinti 1906 m. Tuometinis savininkas J. Garalevičius komerciniu tikslu praplėtė pastogę, išmūrijo didžiulius neproporcingus timpamus, kad tokiu būdu padidintų nuomojamąjį plotą (5 pav.).
