Lars Bengtsson

THREE CROWNS - THE ROYAL CASTLE IN STOCKHOLM

Remains of the medieval castle concealed beneath the plaster of the present-day Baroque facade

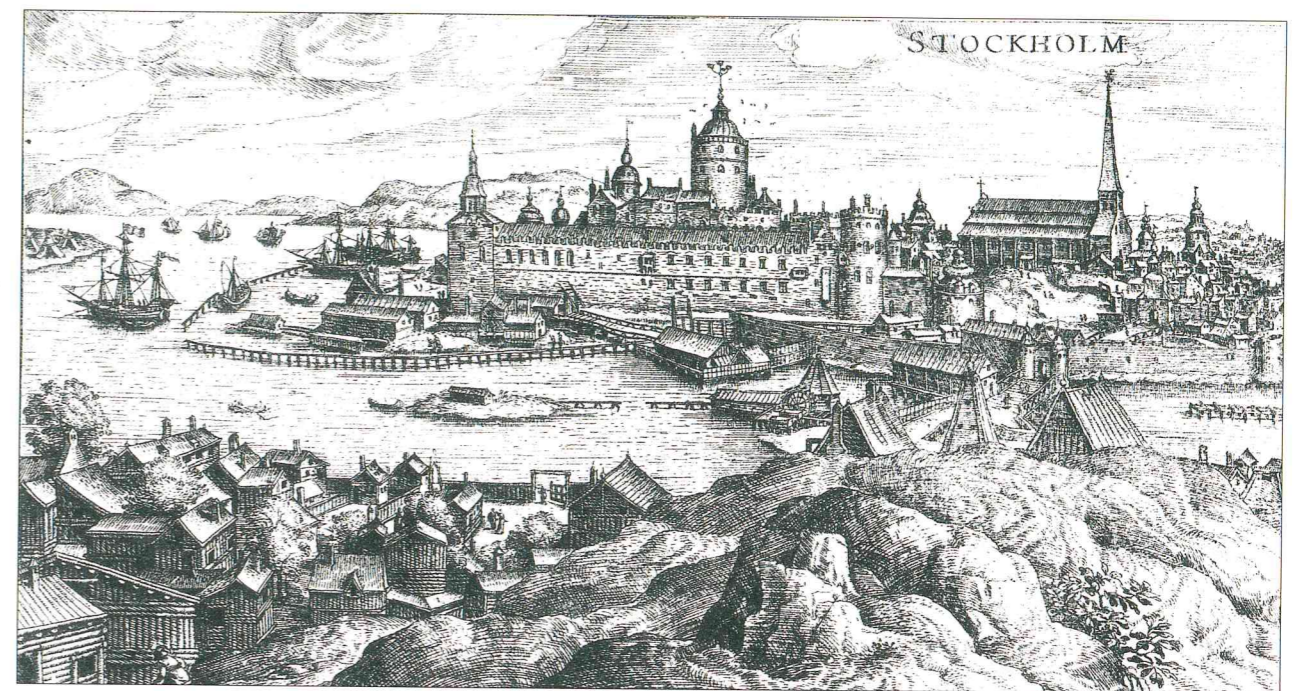
Fig. 1. Stockholm, the city and castle Three Crowns viewed from the north. The castle church, with its tall windows, is housed in the eastern section of the northern wing. There is no documentary evidence suggesting that the NW tower was round. Detail from an engraving by Frantz Hogenberg, ca. 1580–85, before the church was rebuilt and the towers were heightened. Photo, SSM.

The oldest extant illustration of the city with an unencumbered view of the castle as seen from the north is an engraving by Frantz Hogenberg dating back to about 1580 (Fig. 1). The castle church had just been built into the eastern section of the northern wing, i.e. the two-towered building that by then completely enveloped and incorporated in its structure the northern curtain wall. Experts have considered this engraving to be fairly accurate, depicting as it does not only the urbanised areas of the city but also the castle complex as a whole, where various buildings cluster round the keep at the high, southernmost part of the castle compound. However, studies of the 1954 documents and comparison with the engraving suggest that Hogenberg's rende-

ring of certain essential elements of the northern facade may be called in question. The north-western tower was not round; the many fenestration levels depicted in the western section of the facade have not been substantiated; cantilevers have been recorded at other levels and sections - and so on. These and other details will be discussed in our presentation of the 1954 documentation.

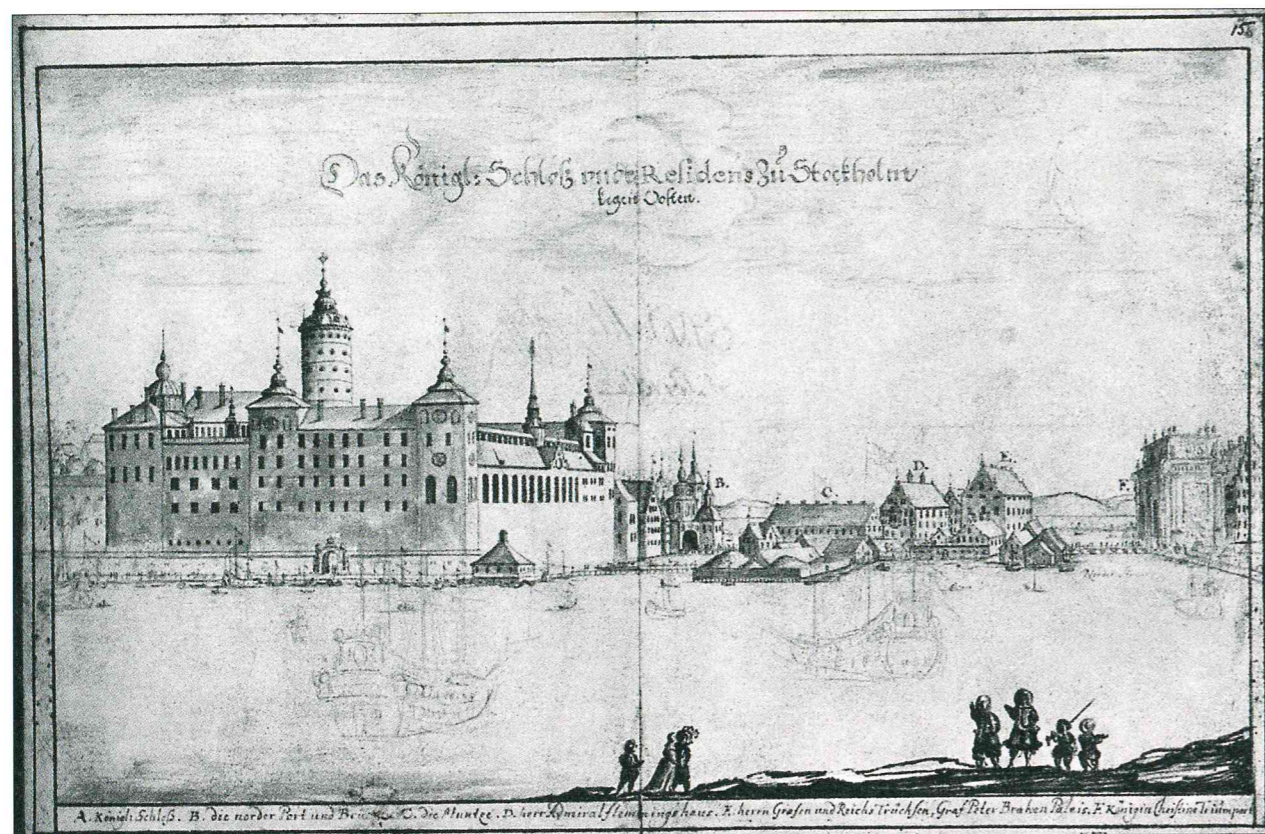
Fig. 2. The castle viewed from the NE, 1669. The sunlit northern wing, with the castle church closest to the observer, is depicted as having a high, smooth base without oriels or cantilevering. Drawing by Erik Dahlberg, National Library of Sweden

Drawings for proposed rebuilding schemes both large and small, the oldest dating back to the mid-17th century, have been preserved to the present day. Most appear to be based on survey drawings dating from about 1660, since that is the year that appears on a complete plan of the castle's top floors signed by Jean de la Vallee. Like the other trades of the castle, the design idiom of the two-storey northern facade was typical of the first half of the 17th century. Both Jean de la Vallee and the German-born architect Nicodemus Tessin the Elder made several drawings for large-scale restoration and rebuilding. It was the son of the latter, Nicodemus Tessin the Younger, who in the 1690s saw his plans for the northern wing actually carried out. Other documents that survive from the second half of the 17th century include those drawn up by Erik Dahlberg, a high-ranking military officer who left behind him large numbers of drawings and sketches depicting details and general views of both the castle and the urban surroundings. Parts of Dahlberg's enormous production were later used for the many engravings that appeared in *Suecia Antiqua et Hodierna*, published in 1716 (Figs. 2 and 14).

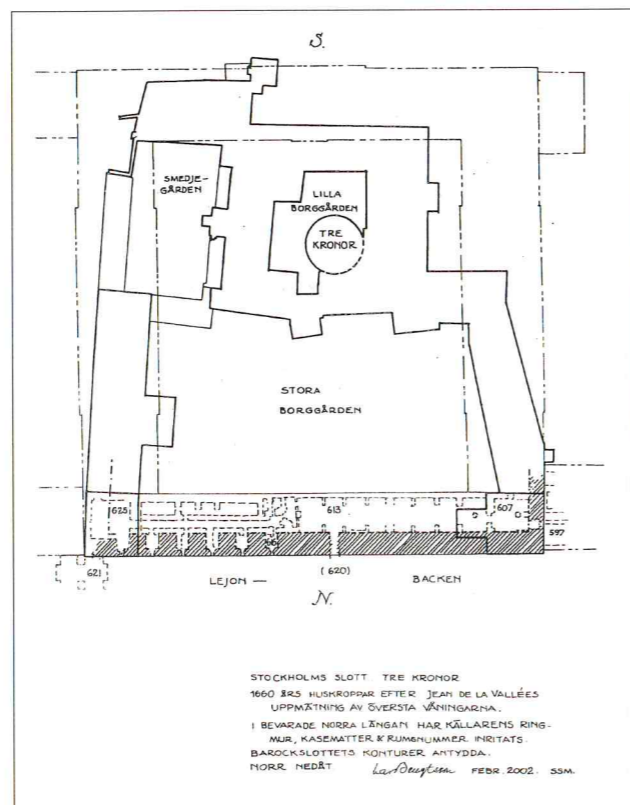
Fig. 3. Stockholm castle. The buildings as they were in 1660 as based on the drawings of the upper storeys made by Jean de la Vallée. The curtain wall of the basement, the casemates and room numbers are indicated in the surviving northern wing along with the contours of the present Baroque castle. North, downwards. Compiled by the author, SSM

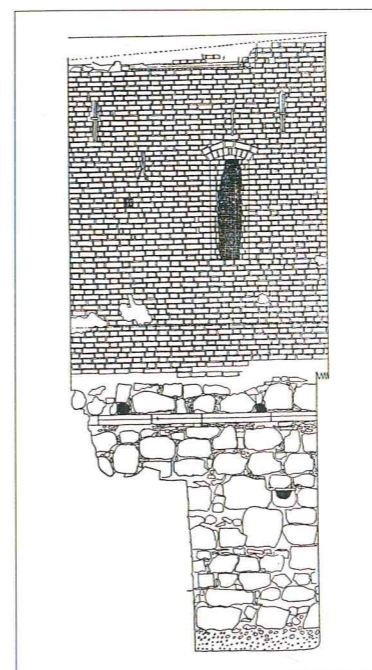
Fig. 4. The lower parts of the curtain wall were documented during excavations carried out in 1926 at the Lejonbacken ramp east of the portal, below window no. 9. The excavations revealed among other things an opening leading in to casemate 616 and a chamfered border ledge. Two beam holes were found on top of the border ledge. A scupper hole was found about one metre below the ledge. After M. Olsson, 1940, p. 43

Further to the west, Olsson and his team dug down to a depth of about 12 metres from the upper part of Lejonbacken, outside window no. 9 (Figs. 4 and 7). The pit-like excavation shaft followed the medieval facade of Flemish bond, skirted a bricked-up opening approx. 30 cm wide and 2 metres high, and continued downwards to a granite bond measuring 60 cm in height. This, in turn, stood on a chamfered stone ledge that formed the link with the underlying and successively widening parts of the granite foundation below. Two deep holes were encountered on top of the border ledge, while just over one metre below the border a scupper hole was found that had apparently once led rain water out from the courtyard behind. A high, narrow opening leading to a casemate (cellar 616) had an archway of headers bordered by another row of headers. This part of the facade had been carefully constructed in Flemish bond. Surprisingly, however, the headers here were plain red rather than heavily fired and black, as in the wall described above and in the walls inside the casemate.

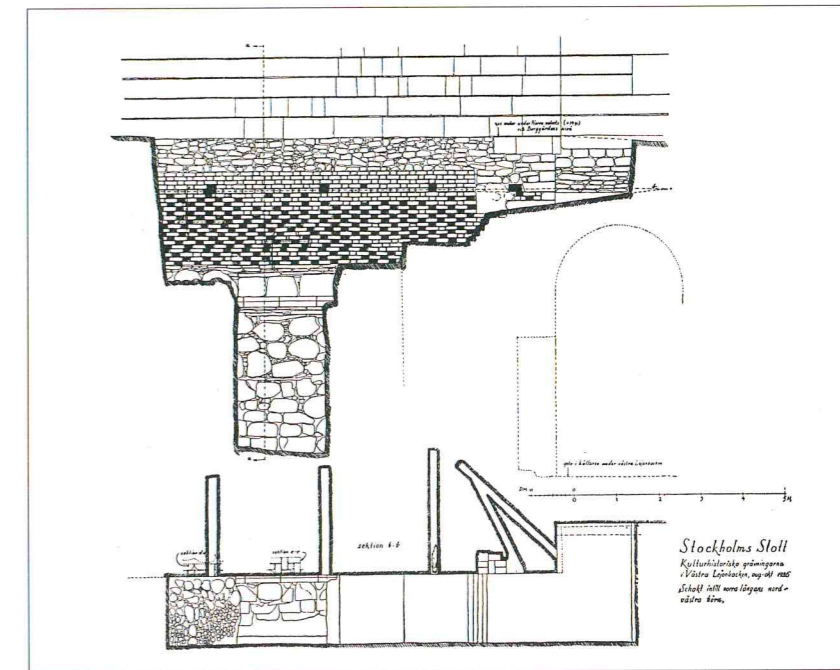
Fig. 5. The NW outer corner of the curtain wall was documented in 1926 in conjunction with excavations at the western end of Lejonbacken below windows 19-20. Section showing the facade and plan. Of particular note are the chamfered ledge, the Flemish-bond brickwork with its heavily blackened headers, and the deep beam holes. After M. Olsson, 1940, p. 38

At the NW outer corner of the castle the team dug down along the exterior of the curtain wall to a level of 7 metres below the Lejonbacken ramps. Although the shaft extended down to +3.60 metres, it was still not deep enough to reach the foundation level (Fig. 5). The appearance of the curtain wall was

the same as those sections already described. The distinctive lower granite bonds were also surmounted by the chamfered border stone, on top of which stood a further 70 cm of granite and, at +8.10 metres, a well-built wall of Flemish-bond brickwork of which heavily fired black headers contrasted with the red of the stretchers. At the +9.80 metre level, the masonry changes character, since above this level the headers are no longer fired black but are coloured an even red. At the same level, the team encountered holes for beams spaced at intervals of about two metres; two more beam holes, running diagonally, were found right in the corner. The holes vary in depth between 2 and 3 metres. The holes in the corner were positioned away from the neatly cut stones that formed part of the original quoins of the curtain wall. Above the +10.40 metre level, a shell wall of small, cut, raw sandstone blocks was encountered; this must have been a secondary structure built to provide a more satisfactory surface for the soil that was to be packed against the wall when the ramps were put in place at the northern side of the Baroque palace. Above this ramp, the ashlar wall, extending up to the ground floor of the palace at approx. +15.5 metres, is a shell of well-cut sandstone.

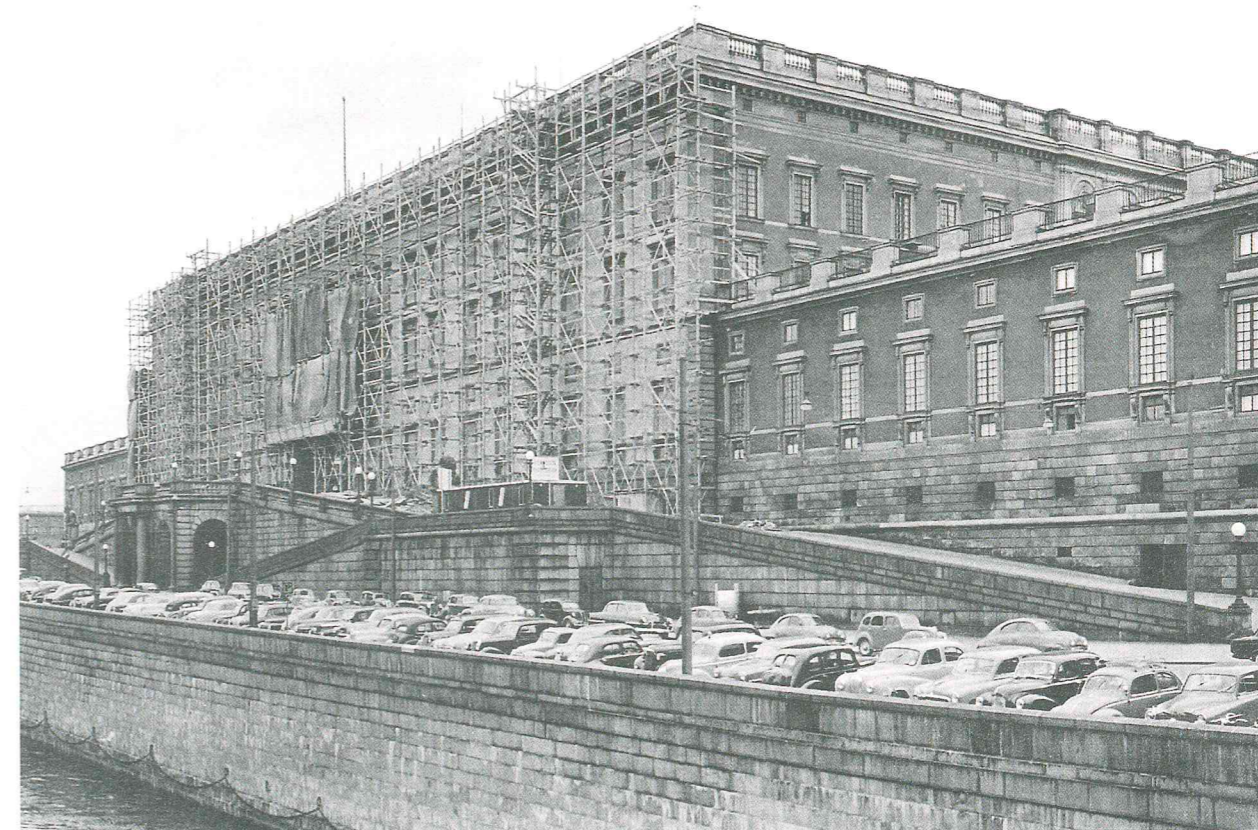
Fig. 6. The castle seen from the NW when the northern facade was renovated in 1954. Photo SAK

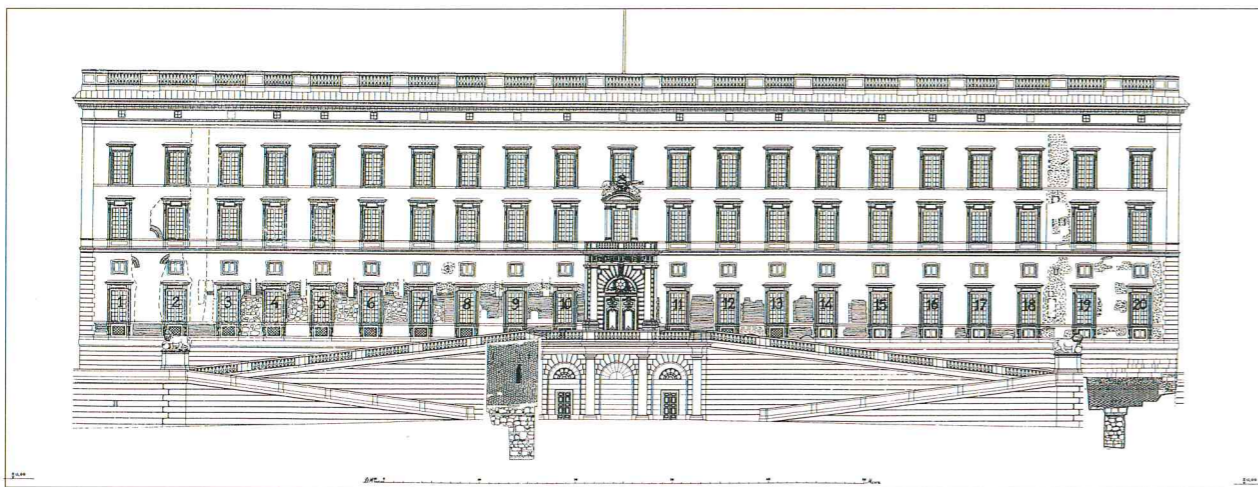
Fig. 7. The northern facade superimposed with the medieval documentation of 1954. The windows are numbered from the east. Granite walls were encountered in the bottom storey between windows 3 to 8. The horizontal lines correspond to medieval masonry dating from different periods. Grid lines indicate the damaged medieval facade with its trimmed-back surface, as at the NW corner tower and above the cantilevering at the loopholes between windows 3-10. As no drawings are available for the NE tower, the findings of the 1890s are indicated by broken lines. Martin Olsson's 1926 documentation of the curtain wall below window 9 and windows 19-20 is also incorporated. Compilation by the author on the basis of drawings in SAK. February, 2002, SSM

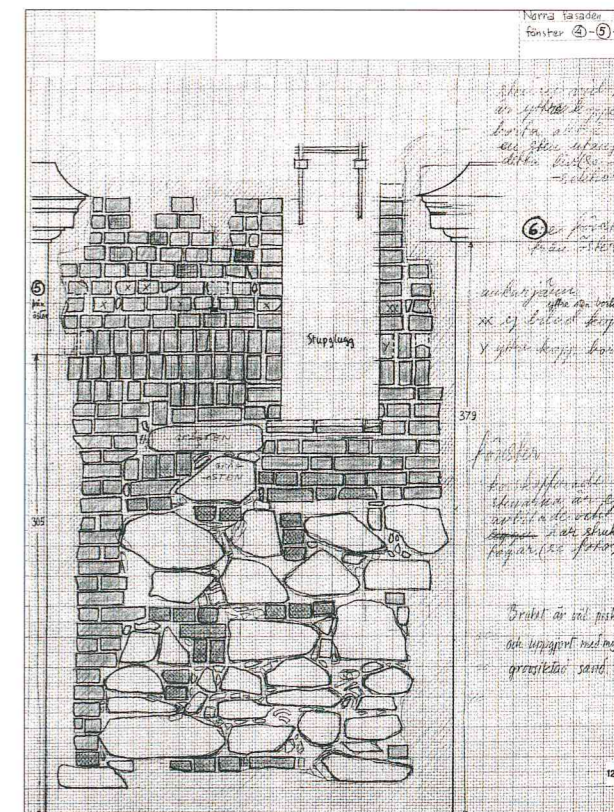
Fig. 8. The northern facade. Documentation of the masonry between windows 5 and 6. The remains of a loop-hole or crenellation are discernible above the granite wall. The brick-on-edge courses at the sides are the remains of cantilevering that has been trimmed back, as has the surface of the brickwork above. Survey: E. Hellenius et al. 1954, SAK

On the ground floor, the entire width of the masonry between windows 3 and 4 is made up of a carefully constructed wall of granite. At the upper part of the wall, the masonry changes to Flemish-bond brick, where the remains of an opening, 65 cm wide, can be clearly discerned. This opening is bordered by three courses of brick-on-edge. These seem long ago to have been trimmed back to the surface of the granite wall below. The surface of these three courses, along with the upper section of the same section of masonry, has been cut off, suggesting perhaps that they once served as a cantilever forming part of an overhanging parapet or battlement. On investigation, the bottom of the opening was found to be steeply inclined, but with vertical sides (Figs. 8 and 9). The remains of this opening is one of six openings of a similar nature recorded in the eastern half of the facade; no such openings are known in the western half. They were probably inclined loop-holes used for shooting missiles from the top of the curtain wall, even though that level has not yet been identified. In the following four sections of the facade, up until window no. 8, there are also the remains of granite walls, each surmounted by bonds of brick, courses of brick-on-edge, and three more loop-holes. The lower level of all three loop-holes was +19.80 metres, and the vertical sides of the openings were constructed of brick and not faced with stone. There is no information as to whether there were any traces of cladding stone in the inclined openings. The openings that have been documented are located well below the crenellation illustrated in the Hogenberg engraving of about 1580.

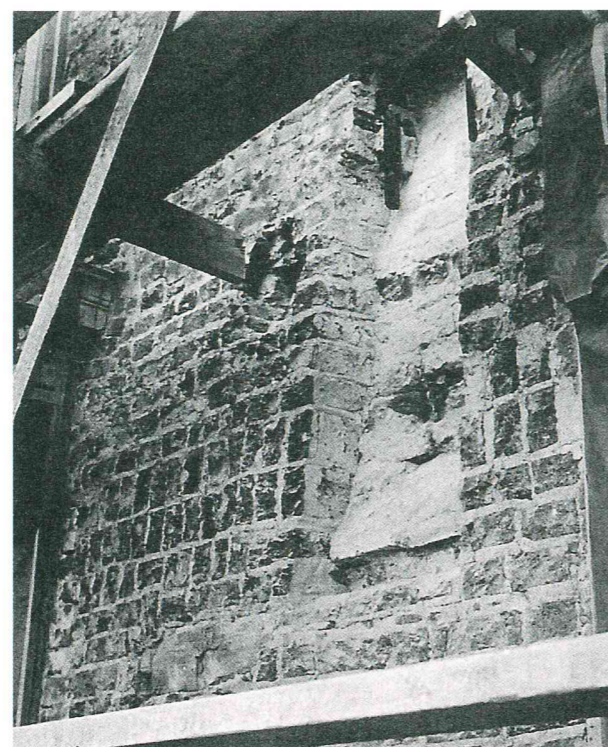
Fig. 9. The northern facade. Loop-hole or part of a crenellation between windows 5 and 6. The brickwork at the sides, from the cantilevering and up, has been trimmed back to the same level as the wall below. Carefully pointed brickwork in the vertical sides. Photo 1954, SAK

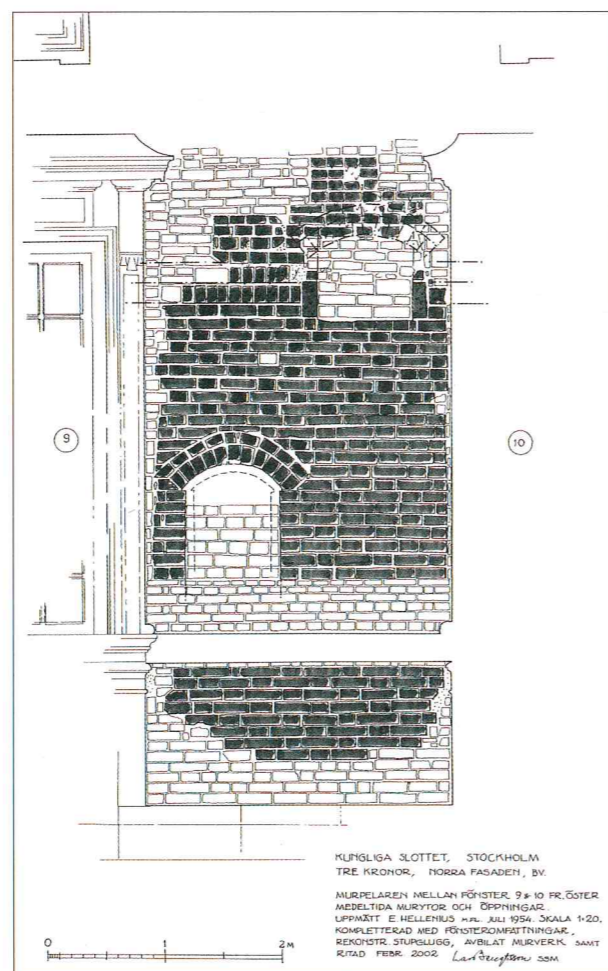
Fig. 10. Medieval wall between windows 9 and 10 with the remains of an opening. Higher up are the remains of a loop-hole. The once cantilevered masonry extending up above the sides, like the corbel stones closest to the opening, has been trimmed back to the level of the wall below. Surveyed by E. Hellenius et al. 1954, SAK. Drawn, with the addition of the reconstructed loop-hole, by the author 2002, SSM

In the two following sections of wall, between windows 8 and 10, the medieval masonry changes in character (Fig. 10). Here, no granite is encountered; instead, there are homogeneous areas of brickwork, carefully put together in Flemish bond, and the remains of a window (?) opening in the lower part of each wall. These had been approx. 80 cm wide and had been topped by half-brick arches. Over one metre above these openings are the remains of two loop-holes at the same level as the others. Unlike the previous loopholes, however, the two brick-on-edge courses did not extend to the opening itself but stopped at rectangular limestone blocks designed to protect the base of the vertical sides of the loop-holes. These stones were 14 cm wide and 30 cm high, and the trimmed limestone had probably overhung the lower wall like corbels and carried the upper masonry which formed the

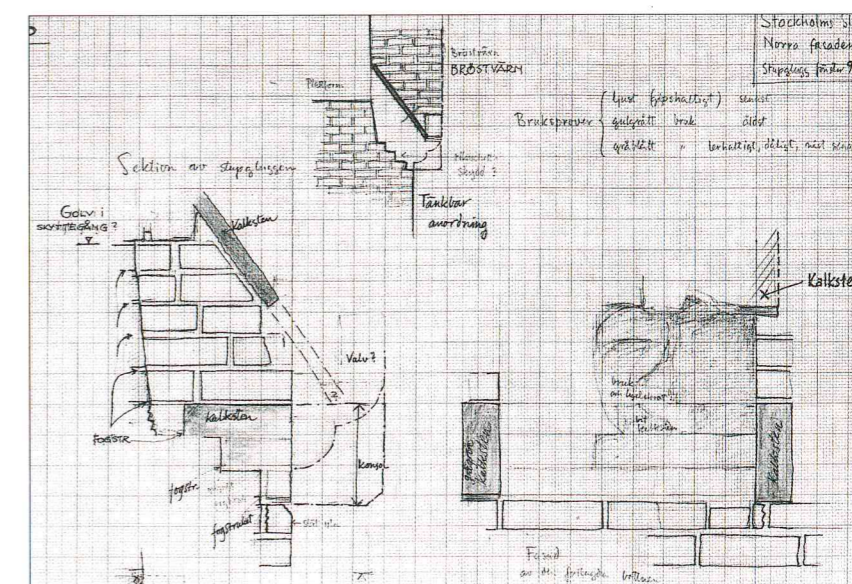
Fig. 11. Remains of the loop-hole between windows 9 and 10 with trimmed-back corbel of limestone and carefully pointed brickwork in the sides. Scale 1:10 field drawing showing section and facade and, above, a reconstruction sketch. E. Hellenius 1954, SAK

parapet. When the bricked-up opening between windows 9 and 10 was opened and investigated, the remains of an inclined limestone slab was found in situ which covered the similarly inclined loop-hole (Fig. 11). This proves that the opening had not been part of a crenellation but was an actual, inclined loop-hole. The appearance of this hole in the facade is unknown, although its construction suggests that the front could have been covered by an arch of brick, 30 cm deep, 15 cm or 30 cm high, that had supported the upper masonry. The height of the parapet above the cantilevering remains unknown, although the lower course of brick-on-edge was the same height as the base of the corbels. The original upper level of the curtain wall, behind the parapet, has not been identified.

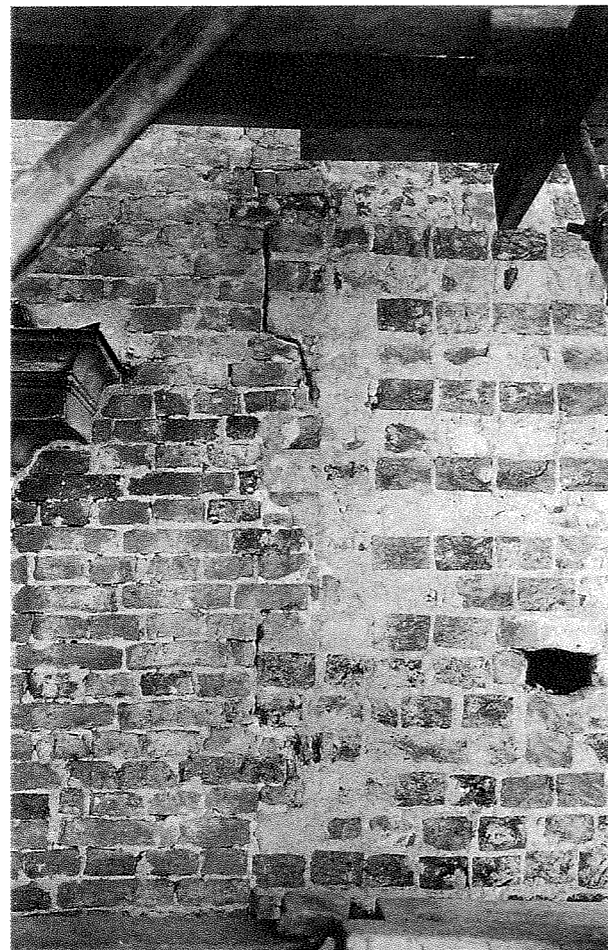
Fig. 12. Western corner tower of the northern facade. Brickwork masonry in the upper storey extends up to the cornice. Impressions in the wall, with remains of mortar in every other course, suggest that a brick shell approx. 15 cm thick has been removed from English-bond or cross-bond courses. The NE corner of the tower may be seen rising above the intermediate building. Photo SAK.

The masonry around the two most westerly windows, nos. 19–20, is associated with the former NW tower. In 1954, all the old masonry of the tower walls, extending up to the cornice, was shown to have been extensively damaged, and it appears that what the investigators had encountered was actually the core of the wall at the lower floor levels and part of a cut shell in the facade at the top floor. According to the photos, it seems that the shell had been trimmed back by some 15 cm to a depth of about half a brick (Fig. 12). When the outer shell – which was probably constructed of brick bonds – was removed is un-

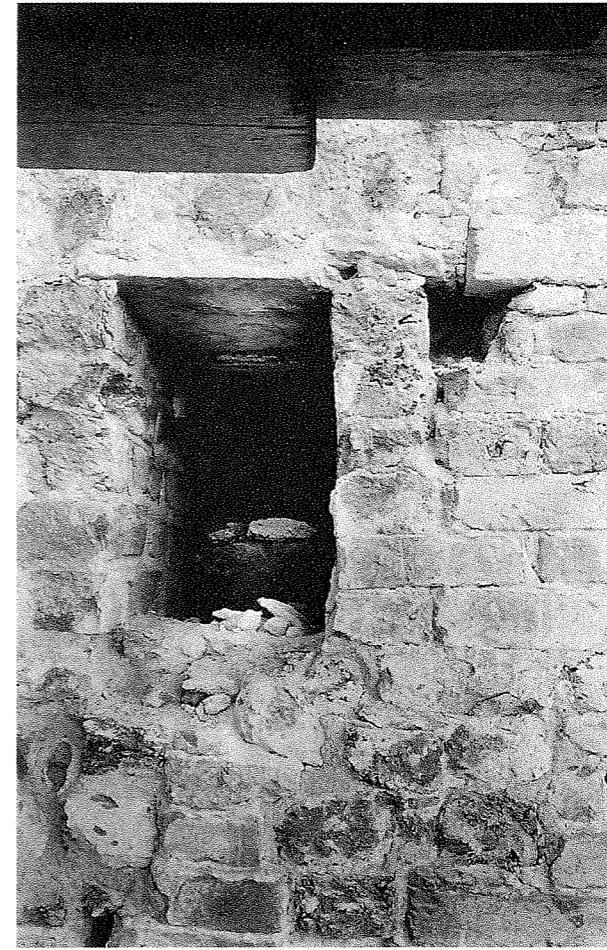
Fig. 13. A small opening with a limestone covering that may once have served to light up a spiral staircase running behind the wall up to the 2nd storey of the NW tower. The original brickwork has been trimmed back and, as in other places, the adjacent surfaces to the right were replaced in the 17th century by a new brickwork shell. Photo SAK.

have been provided to light up narrow spiral staircases (Fig. 13), while a large bricked-up section have served as a passage to an oriel or perhaps an overhanging privy. The 1954 investigations also recorded an impression in the wall at +34 metres between windows 18 and 19 that has been interpreted as the former site of a sloping roof.

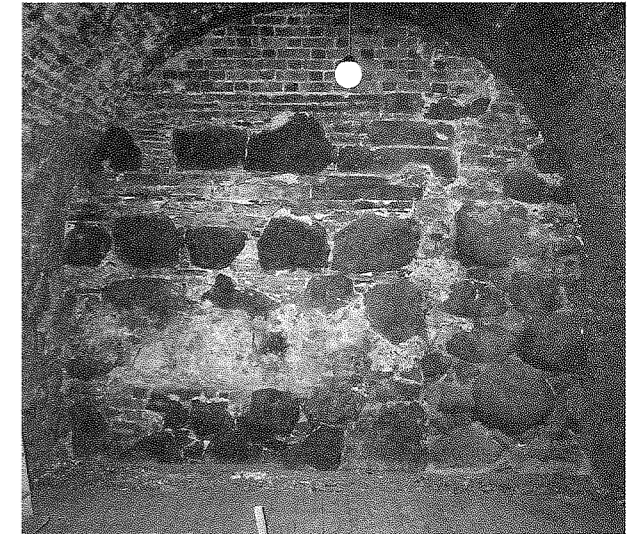
Fig. 14. The castle. The western facade of the original curtain wall is discernible at the NW corner in cellar 597. This illustration supplements M. Olsson's surveys of 1926, figs. 4 and 5, and shows medieval granite with a chamfered ledge and upper Flemish-bond brickwork with heavily blackened headers. Photo by the author 2001, SSM.

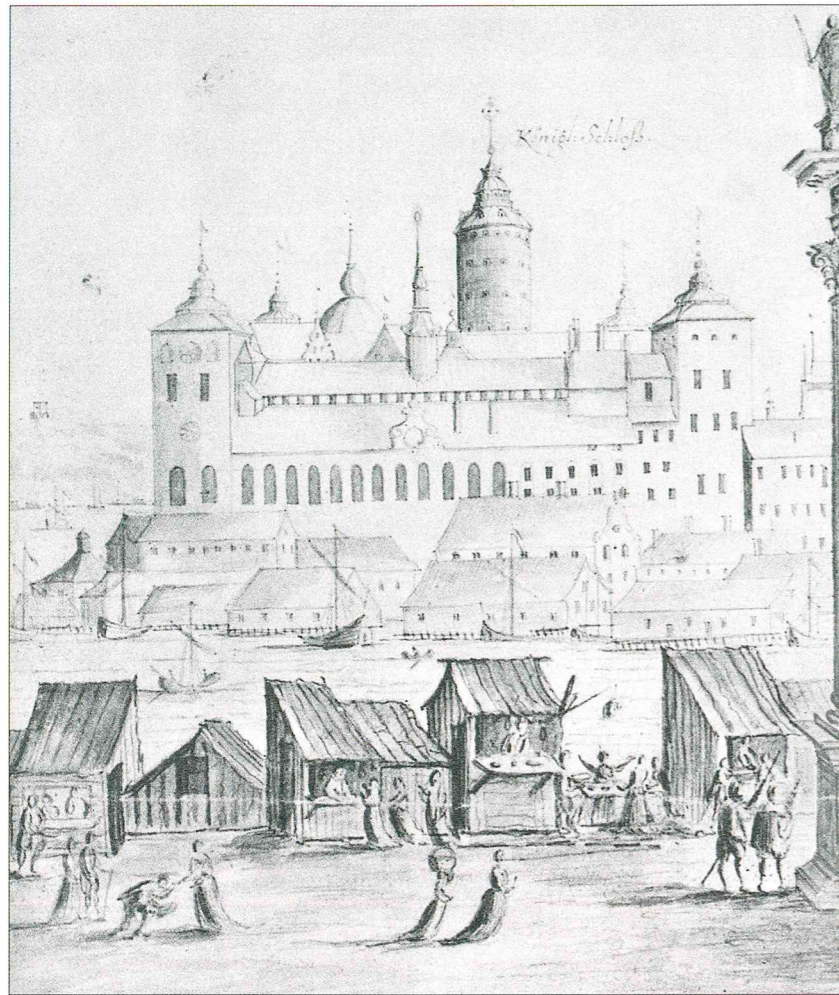
Fig. 15. Stockholm castle viewed from the north in the 1660s. In this drawing by Erik Dahlberg, the high base of the northern wing, the curtain wall, is concealed by the buildings of Helgeandsholmen. The church windows correspond to the windows in today's high lower storey and entresol. The two storeys added in the 1690s were in principle built up from the foot of the roof of the building between the towers
